Avon River Aboiteau and Causeway Upgrades: Pre-Construction Monitoring of the Avon River Estuary

Graham, J., Bowron, T.M., van Proosdij, D., Baker, G., Ellis, K.

CBWES Inc.

March 2018

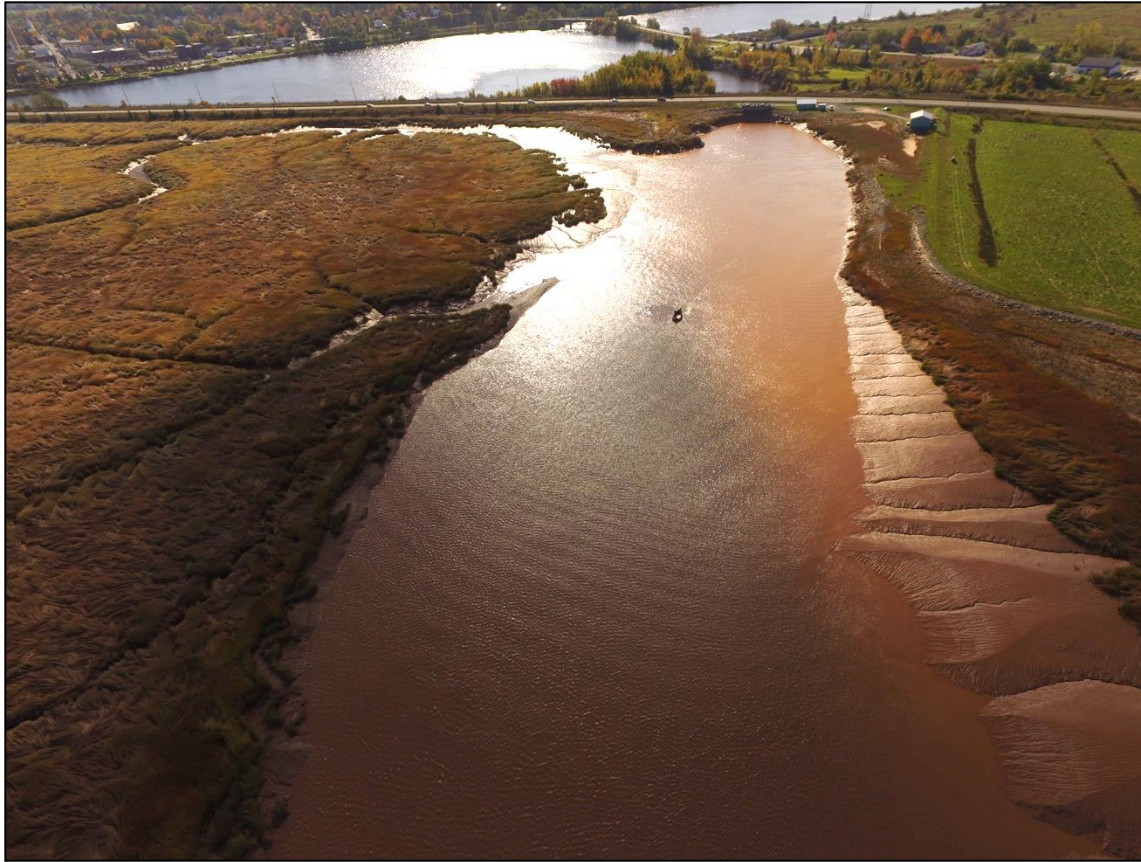
Figure 3 Oblique aerial image taken October 20, 2017. UAV hovering over Tide Gate Channel looking south towards causeway.

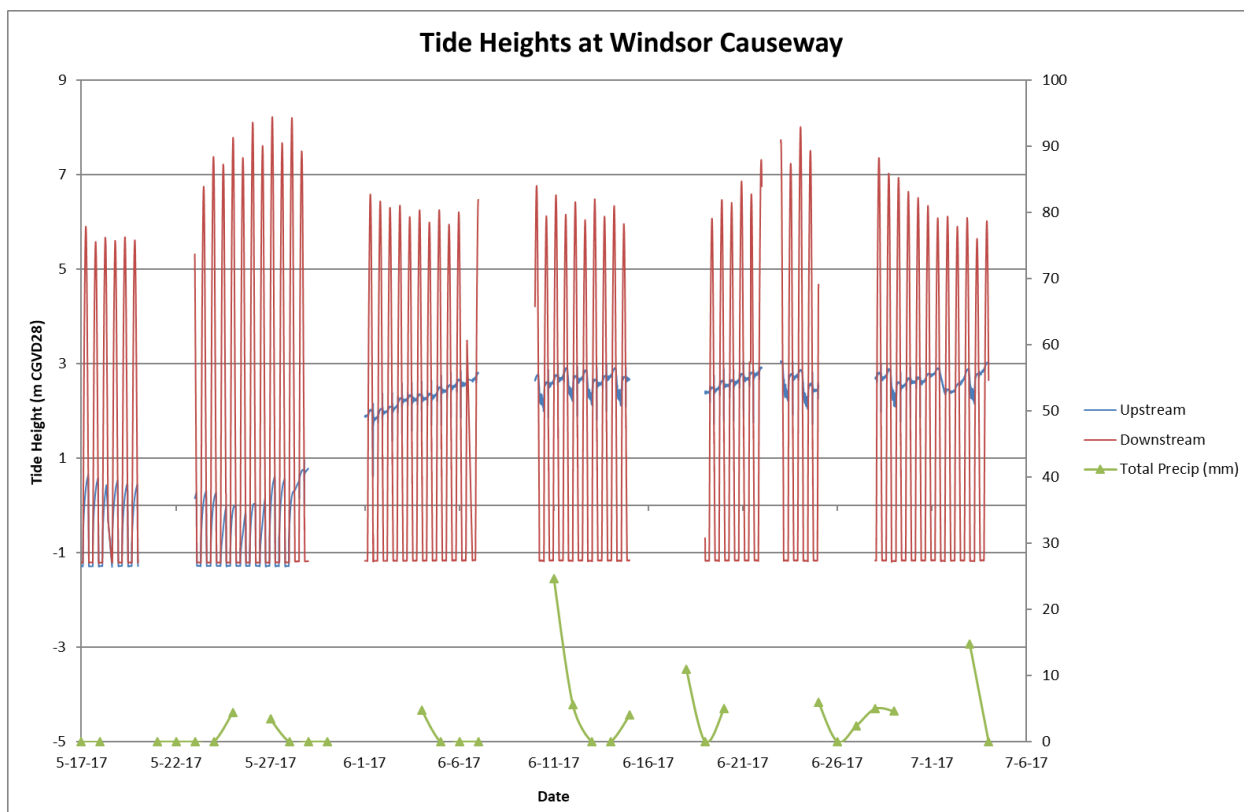
Figure 10 Tide signal at Windsor Causeway with upstream water level (Lake Pisiquid) and rainfall amounts (White Rock, NS).

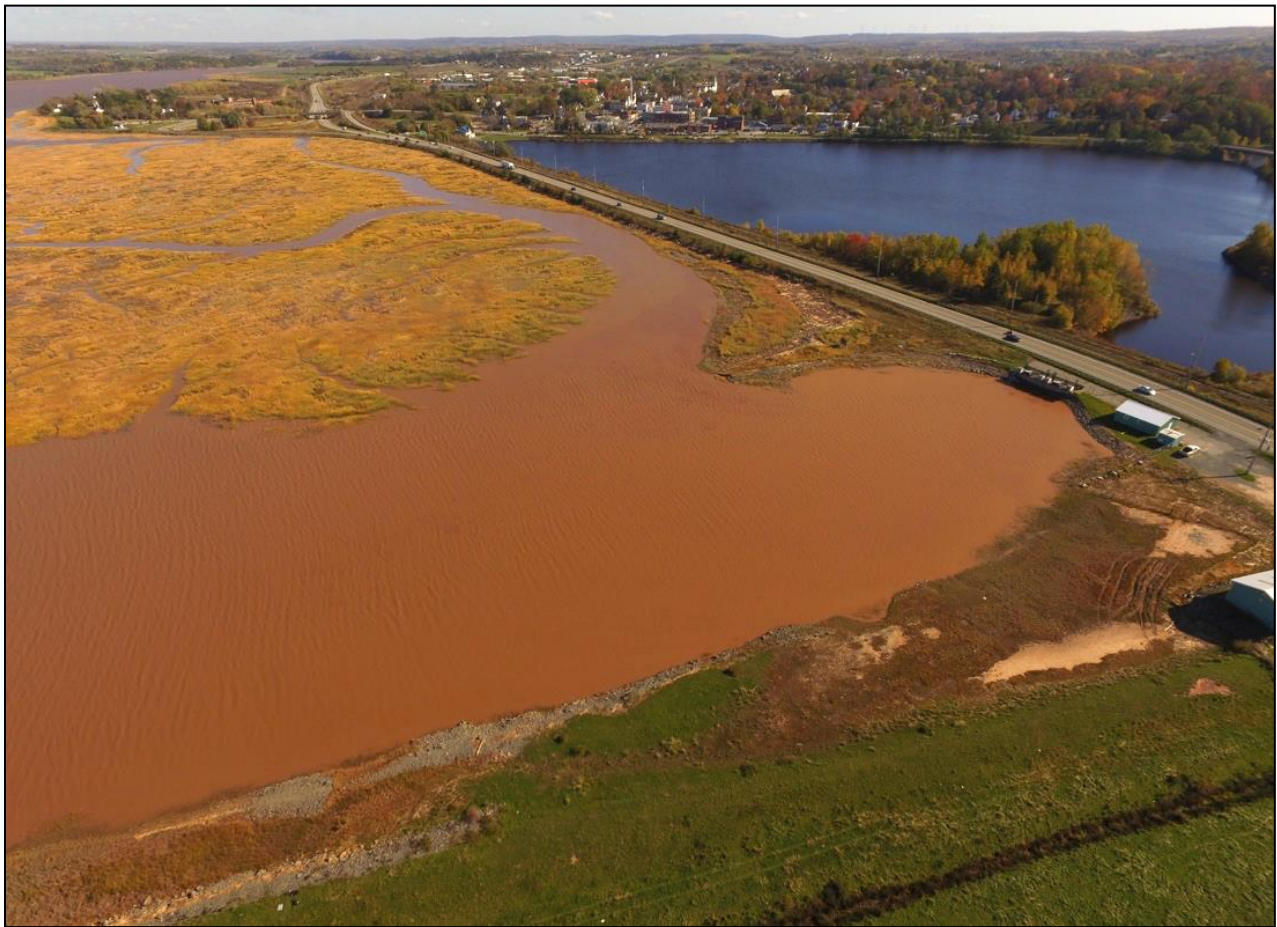
Figure 15 View of high tide at causeway on October 20, 2017 from above Elderkin Marsh.

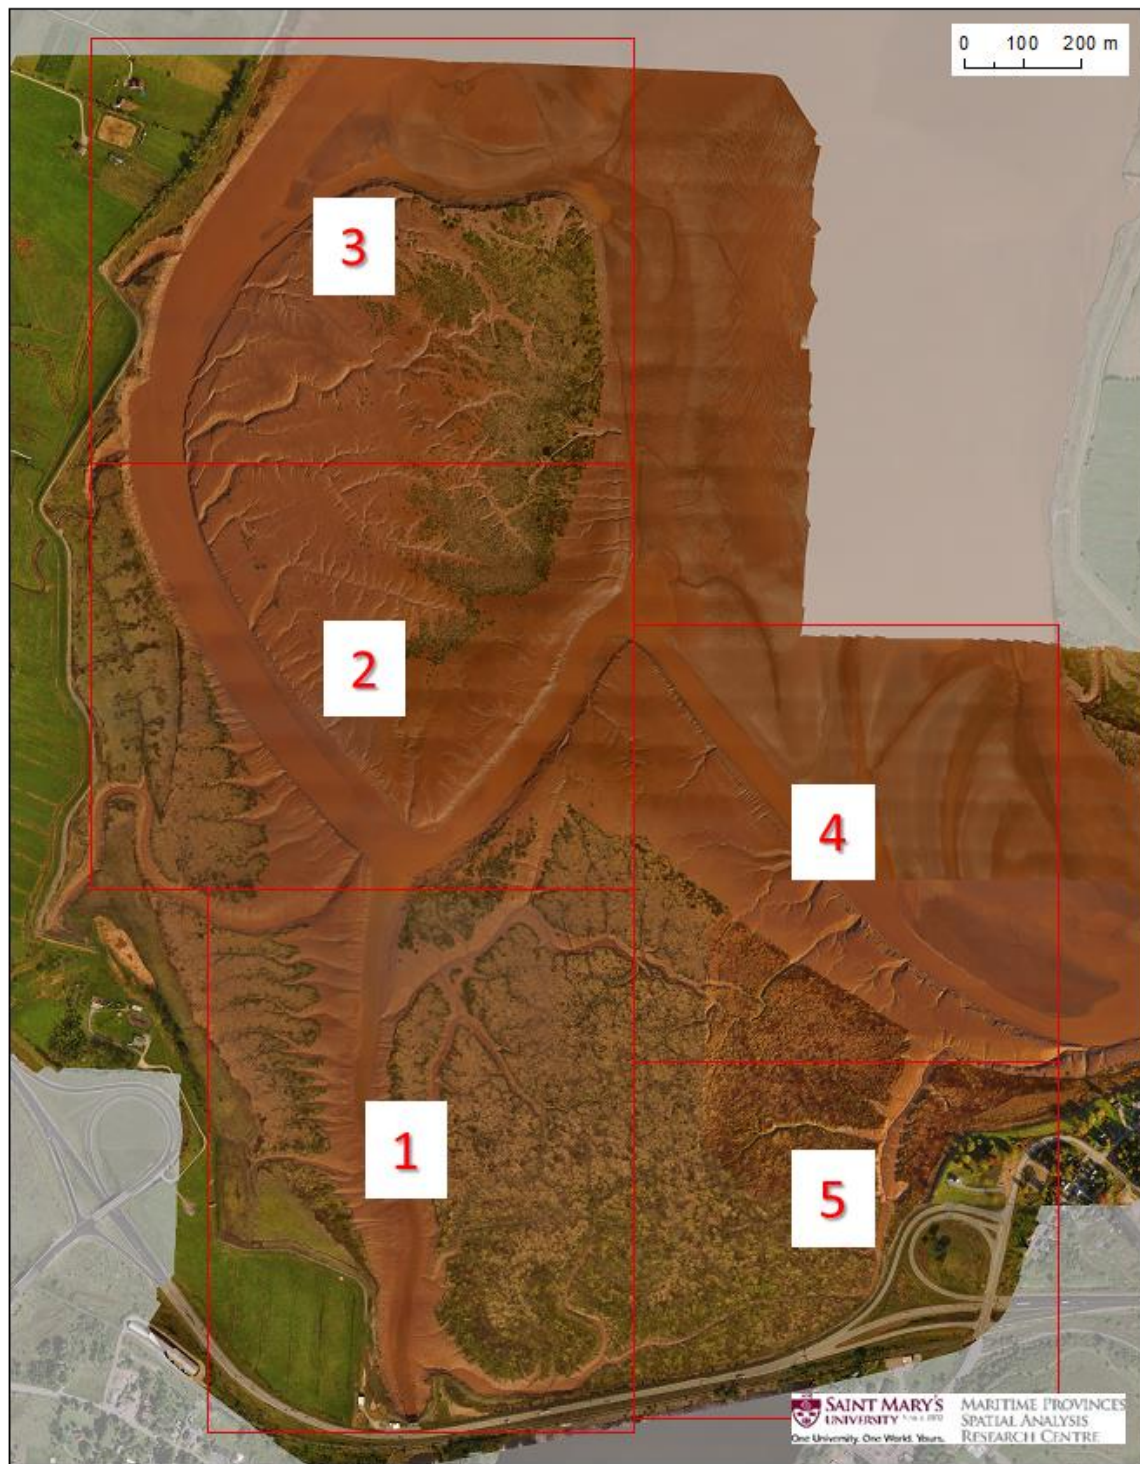
Figure 16 Delineated sections of study area used for the ecomorphodynamics analysis. 1) Tide Gate Channel; 2) confluence Avon and St. Croix Rivers; 3) Newport Bar; 4) St. Croix and East marsh and 5) Eastern Tide Channel.

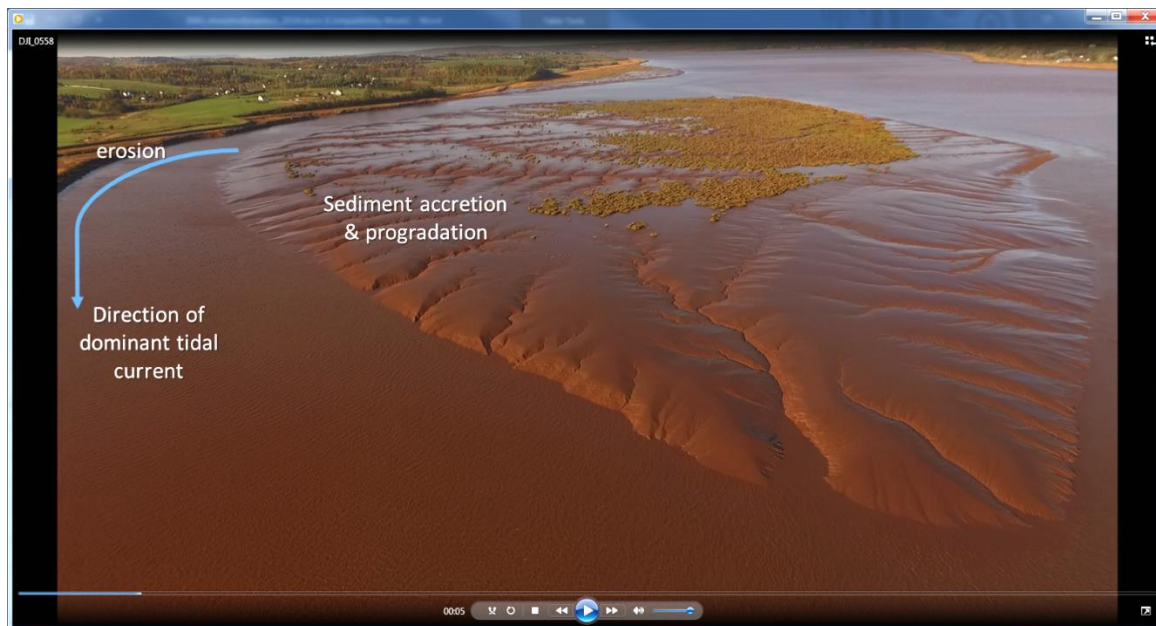
Figure 23 Screen capture of drone-based video of hydrodynamics along the Newport Bar and Elderkin Marsh on October 20, 2017.

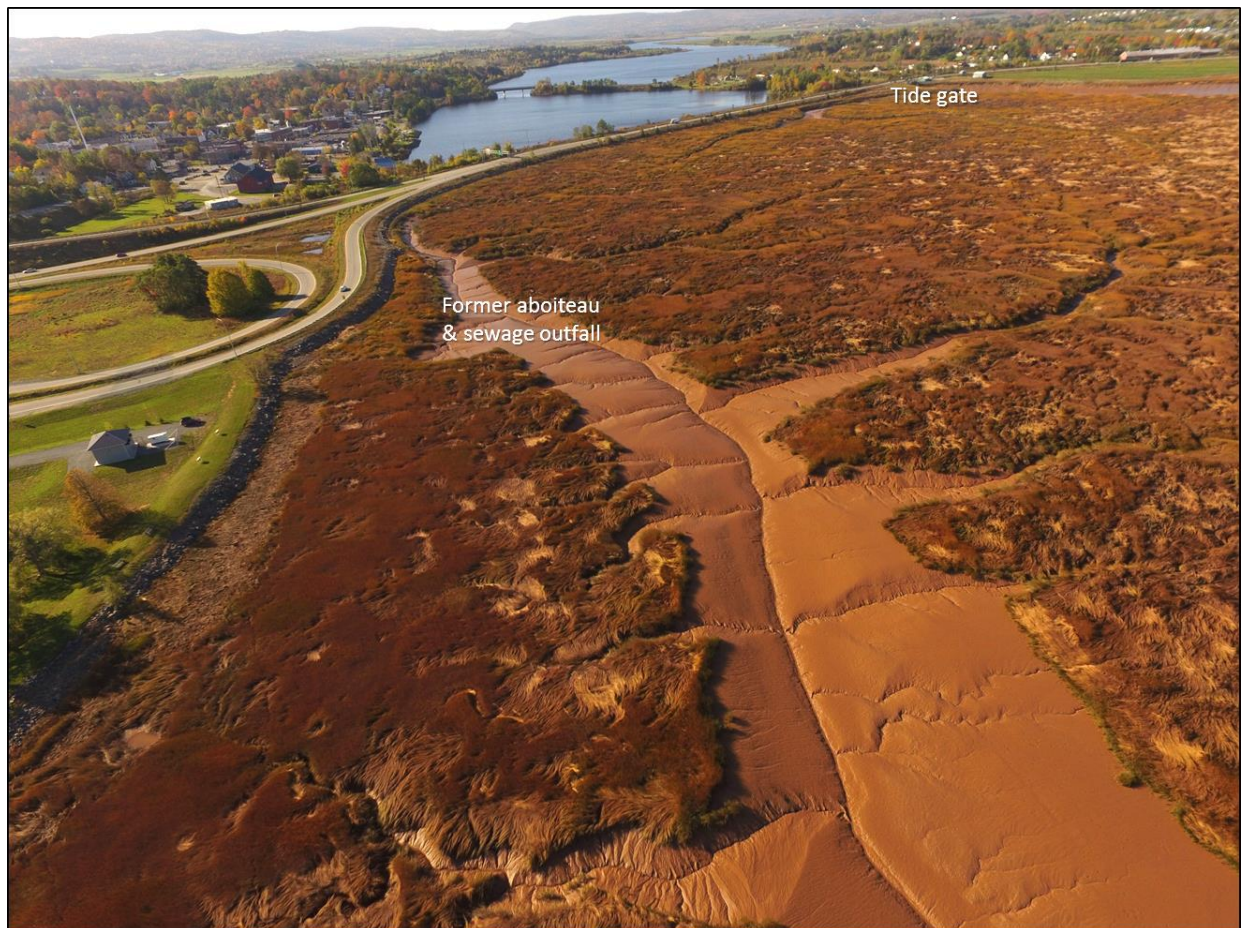
Figure 27 Oblique aerial image captured October 20, 2017 of Eastern Tidal Channel and former sewage and aboiteau outflow.

The study area was divided into five discrete sections for analysis and discussion. As mentioned previously, due to the increased spatial coverage and accuracy of the 2017 orthomosaics and DSM compared with 2016, the boundaries of these sections were expanded, offering a more comprehensive analysis (Figure 16). Section 1 focused on the Tide Gate Channel (Figure 15), Section 2 addressed the dynamic confluence of the Tide Gate Channel of the Avon River and a side channel from the St. Croix River south of the Newport Bar. This section also included foreshore marsh adjacent to Elderkin Marsh (Figure 6). Section 3 focused on the Newport Bar that began to develop in the mid-1990s downstream of the main Windsor Salt Marsh. Section 4 encompassed the northeastern section of Windsor Salt Marsh along the St. Croix River and near the former Tourist Bureau. Section 5 focused on the Eastern Tidal Channel adjacent to the Highway 101 Exit 6 ramp which previously handled the flow from the now decommissioned aboiteau and sewage outflow from the town of Windsor.

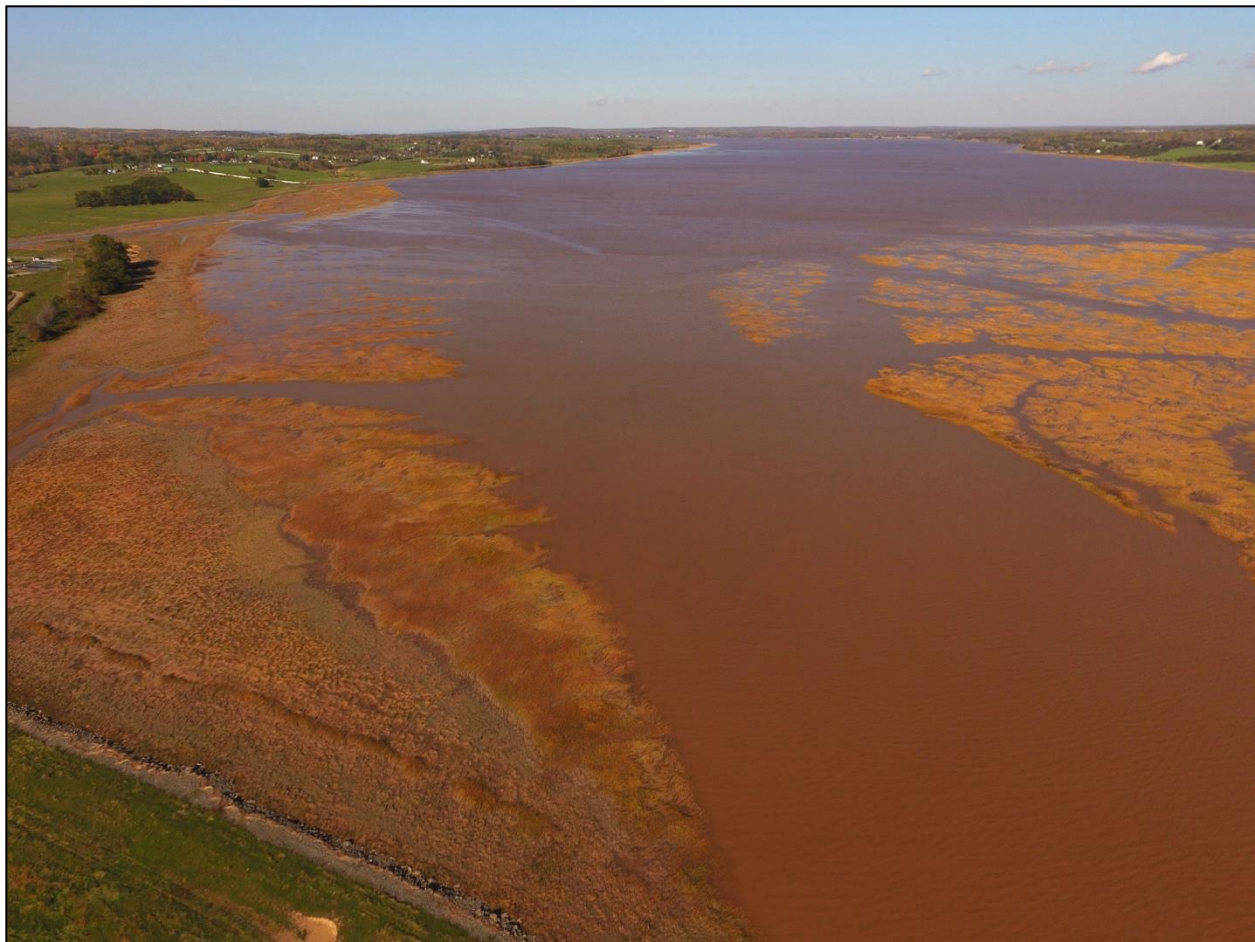
Figure 33 Oblique aerial image taken at high tide on October 20, 2017 looking North from tide gate. Note the fully submerged Newport Bar and tops of tall *Spartina alterniflora* on both the Windsor and Elderkin Marshes.

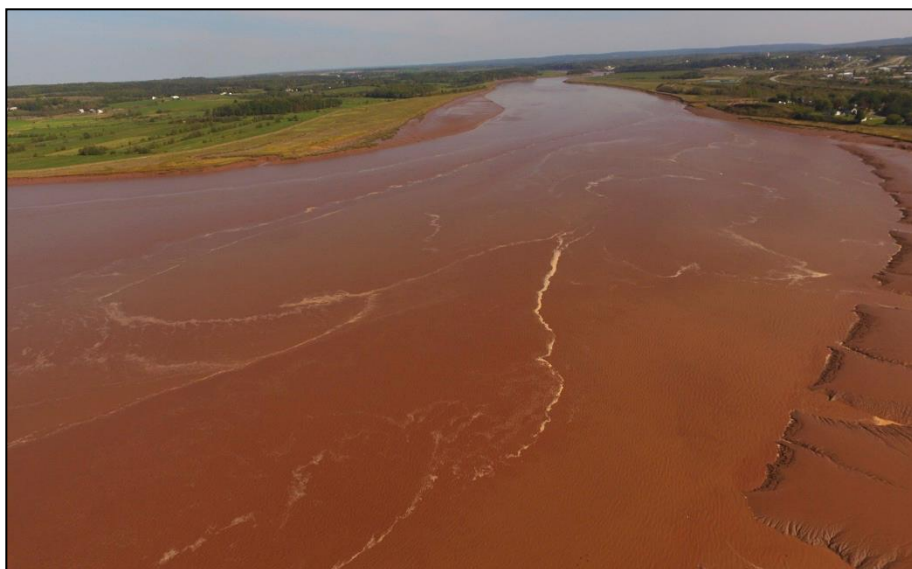
Figure 39 Converging flow on flood tide from main Avon Channel and secondary channel parallel to main Windsor Salt Marsh, entering into the St Croix River on October 20, 2017.

strongest currents arose during the flood tide as the tide waters are constrained between intertidal bodies and vegetated platform (Figure 21, Figure 25, Figure 39). Having now demonstrated the capabilities and benefit of UAV video footage for monitoring and analysing hydrology in a complex system like the Avon River, it is recommended that this be expanded upon in future studies.

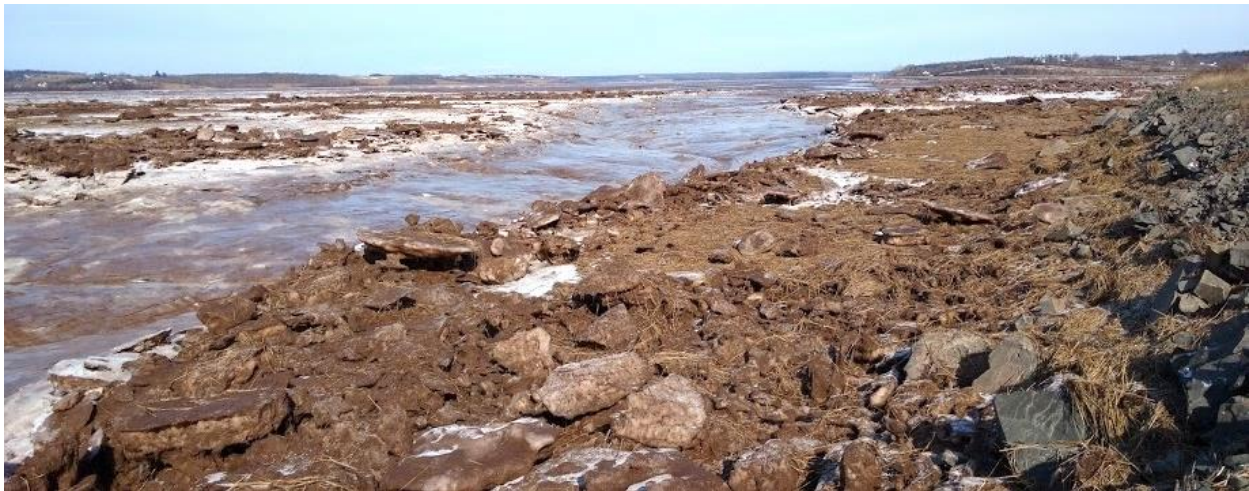
Figure 42 Eastern channel and foreshore marsh showing limited ice build-up on the platform or in the channels (7 February 2018).

Winter 2017/2018 experienced generally warm wet conditions punctuated by short intermittent cold periods. Ice formation was limited, and snow rarely accumulated with most precipitation falling as rain. The structured winter walk was conducted on February 7, 2018 on a clear day at low tide during one of the colder periods of the winter. Figure 42 shows the build up of ice cakes at the site and a thin ice crust that has formed over the banks of the channels. Ice cakes were mainly restricted to the lower sections of the marsh close to the river and tidal channels (Figure 43). There were some wrack and sediment deposits that indicated that larger tides and winter storms had moved ice and materials into the upper sections of the marsh (Figure 44). Many of the bamboo rods marking the transect end points and vegetation sampling stations were still present and intact, indicating that there had not been significant disturbance from storms or ice prior to the winter walk (Figure 46). During site visits by members of the research team in previous years during winter months, significant ice formation has been observed, with individual blocks greater than 10 feet high. Late February and March 2018 experienced several large winter storms with high winds and storm surges that may have changed the conditions observed at the site during the winter walk.

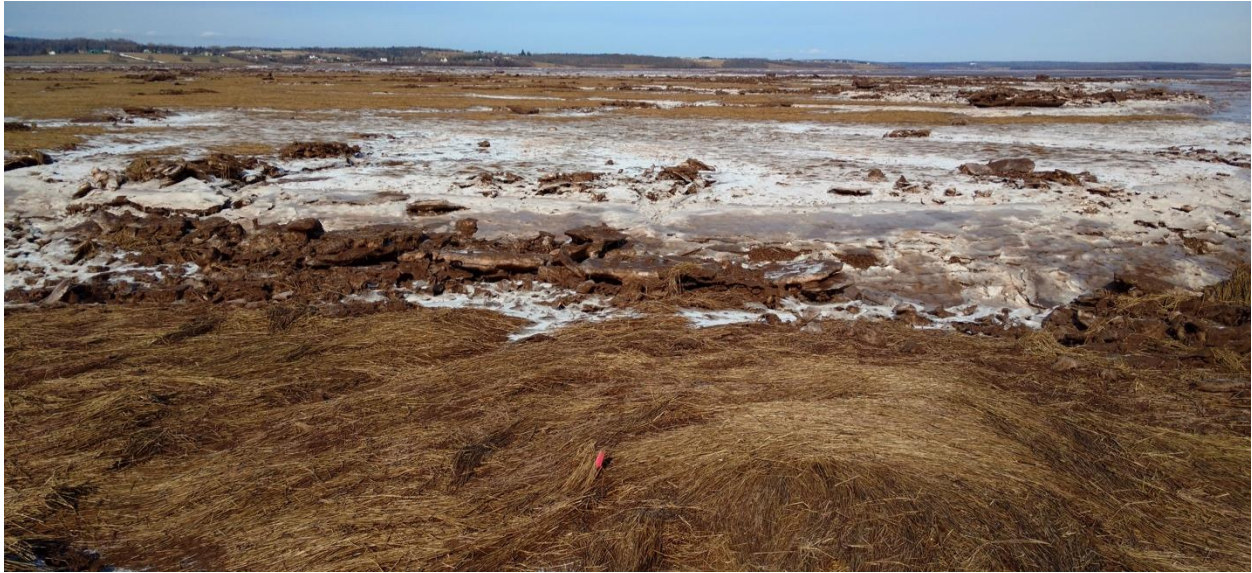
Figure 43 Windsor Salt Marsh showing distribution of ice at the site (7 February 2018).

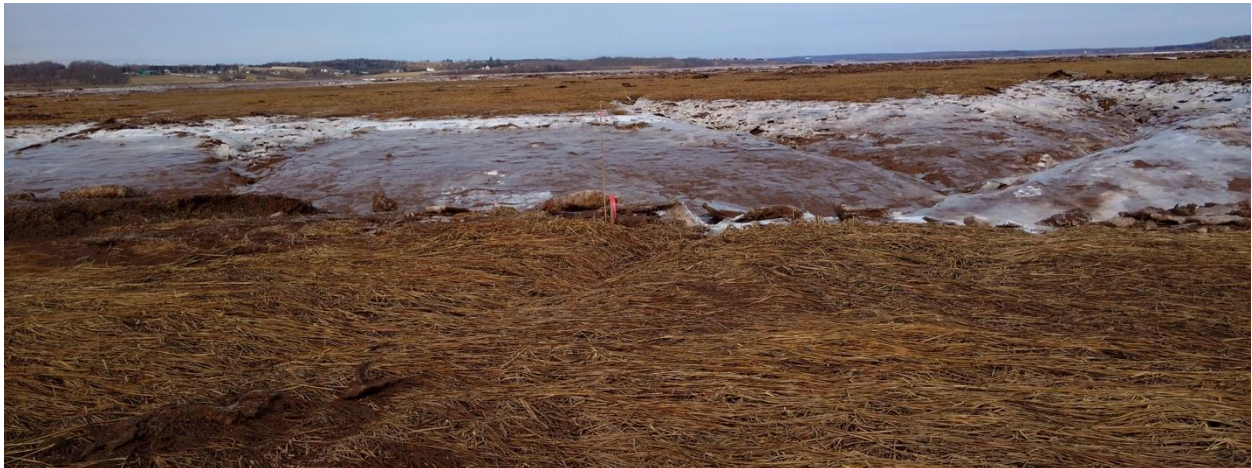
Figure 44 Exposed marsh surface with extremely limited ice rafting and minimal surface within the tidal channel (7 February 2018).

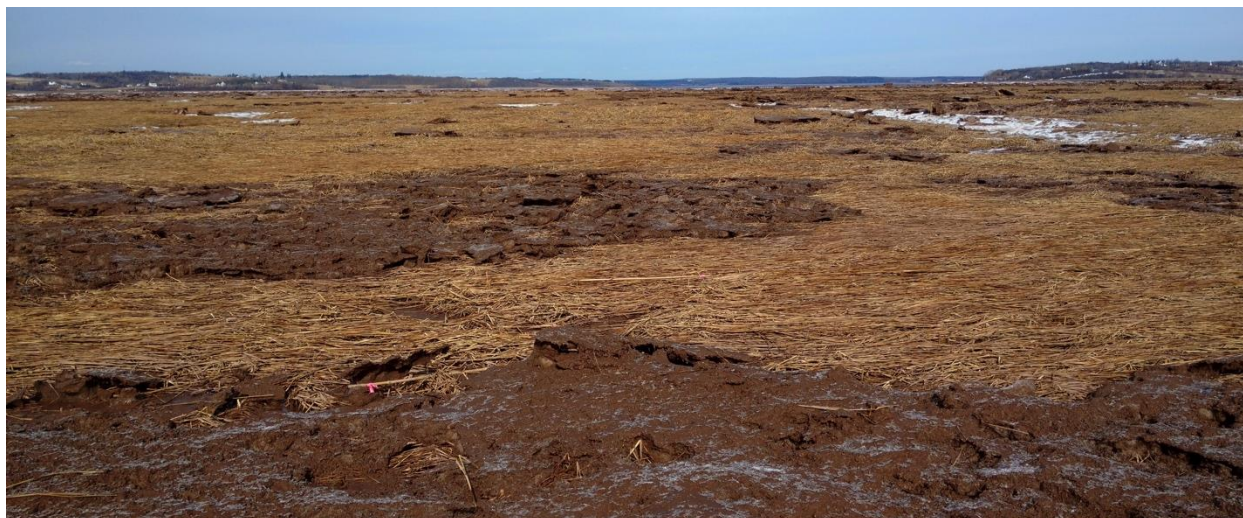
Figure 45 Sediment deposits in the upper section of the marsh (7 February 2018).

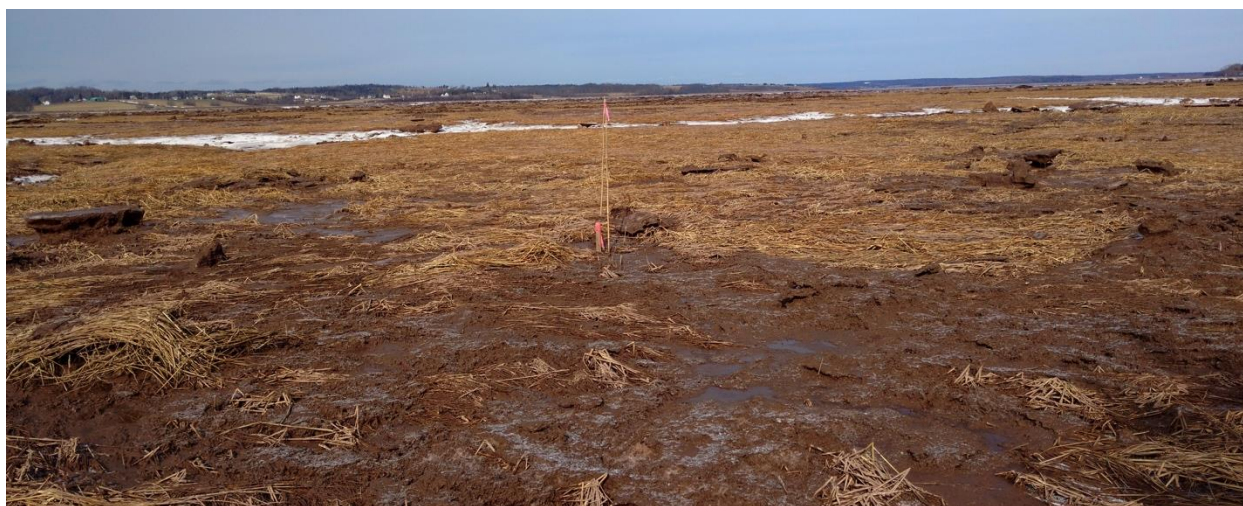
Figure 46 Bamboo transect marker (7 February 2018).
