## Examination of the Morphodynamics of the Upstream Portion of the Avon River

*Final Draft Report Submitted to:*

Lachlan Riehl  
Mi'kmaw Conservation Group, Confederacy of Mainland Mi'kmaq

Dr. Danika van Proosdij, Greg Baker and Emma Poirier, Saint Mary's University and Tony Bowron, CBWES Inc.

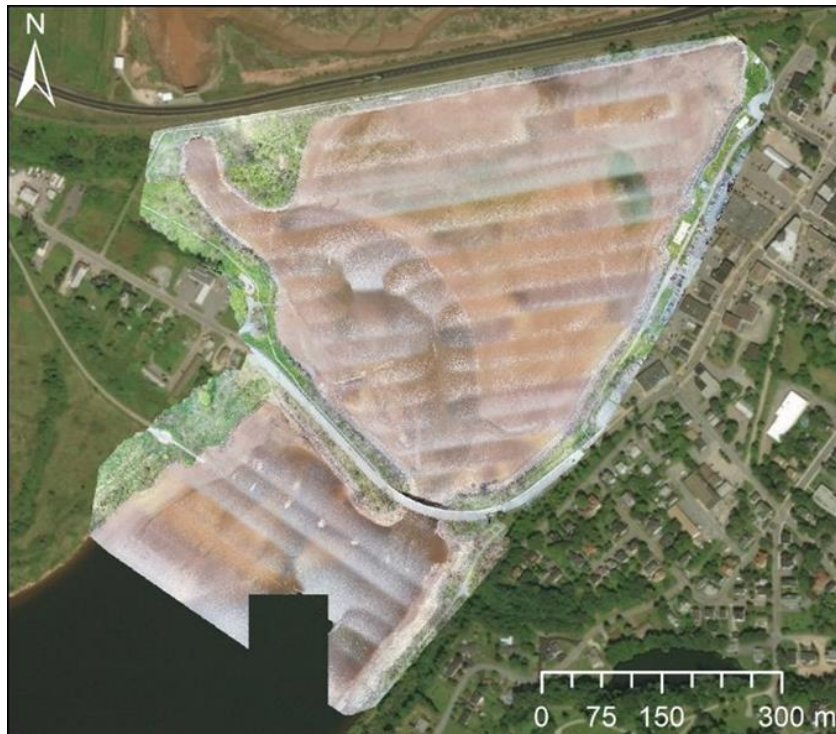
**FIGURE 2: PHANTOM 4 ORTHOMOSAICS OF UPSTREAM SURVEY**

The Phantom 4 orthomosaic has a 2 cm resolution, is in coordinate system NAD83 (CSRS) UTM Zone 20N, had significant issues with sun glint in areas of water coverage and wet mud, and a lack of photo alignment due to water coverage in the southern portion of the dataset resulted in a data gap (Figure 2). The WingtraOne orthomosaics have a 2.5 cm resolution, in the NAD83 (CSRS) UTM Zone 20N coordinate system. These orthomosaics had no sun glint issues, but some striping is present due to variable light levels during collection, particularly in the orthomosaic created for the upstream section (Figure 3).

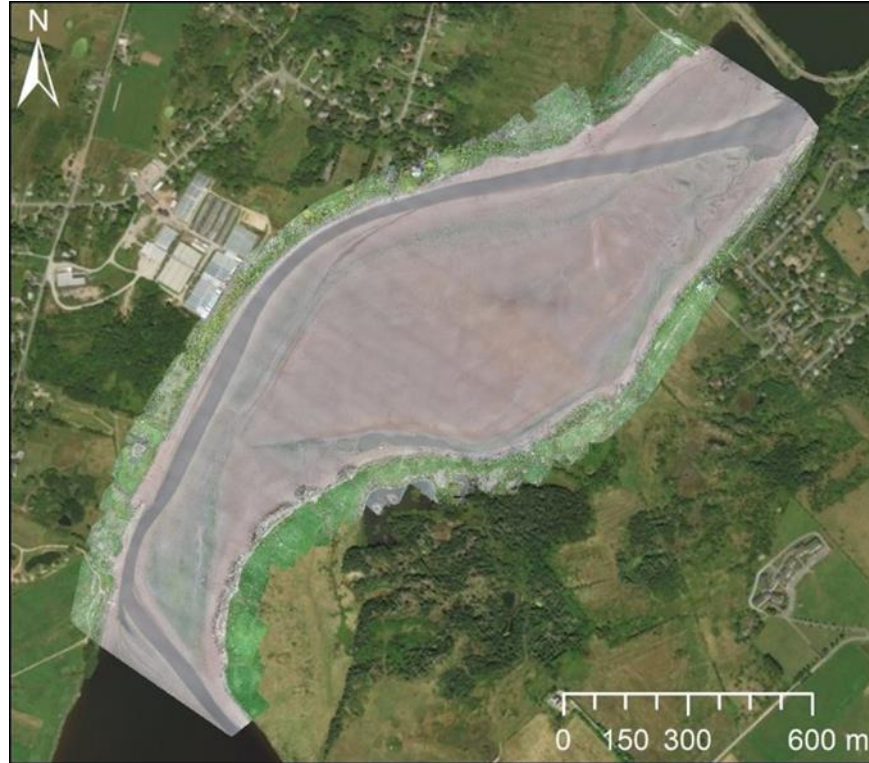
**FIGURE 3: WINGTRAONE ORTHOMOSAIC OF UPSTREAM SURVEY**

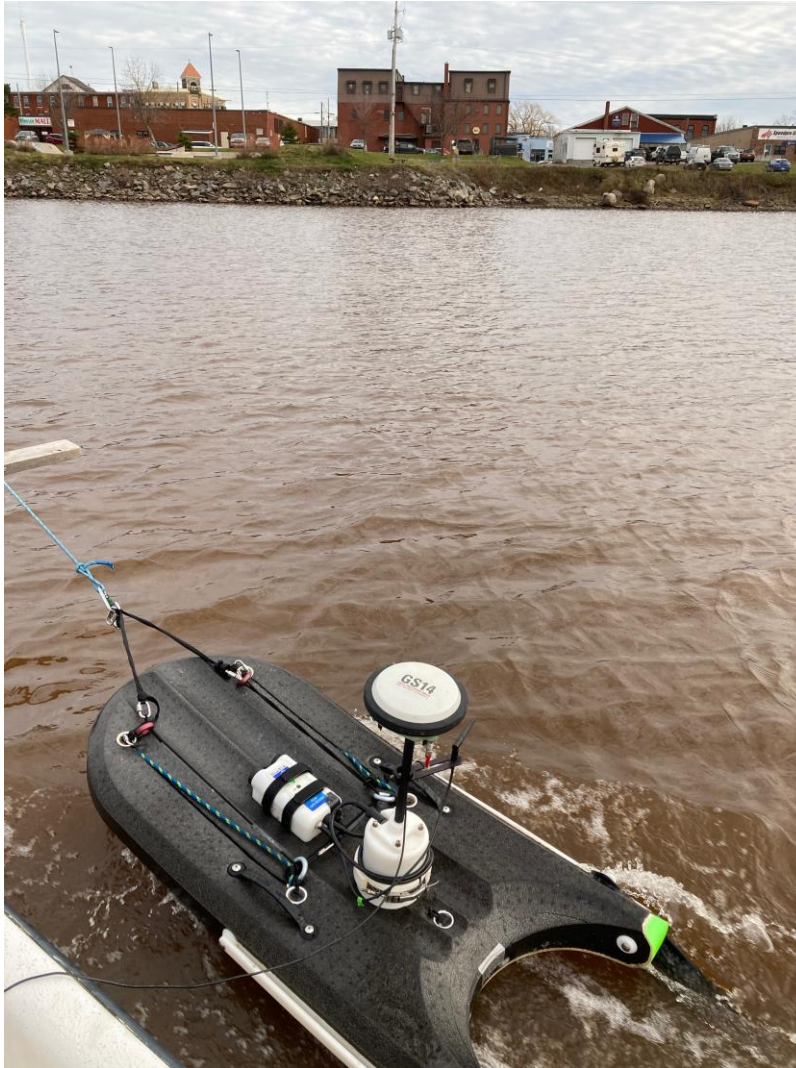
FIGURE 5: SONTEK M9 ON HYDROBOARD FOR BATHYMETRIC SURVEYING, DEC 11, 2020.

The 2020 survey was conducted on Dec 11 by CBWES Inc. using a 16 ft. shallow water fishing boat (Carolina skiff J16), and Sontek M9 (Figure 5) at high water levels. Surveys were conducted cross shore along pre-established profile lines using posts and compass bearings for reference. The boat travelled between 7-8  $\text{km}\cdot\text{hr}^{-1}$  with data continuously recording resulting in data points spaced approximately 0.5-1 m apart. M9 elevation files were imported into an Excel spreadsheet template as Easting (x), Northing (y) coordinates

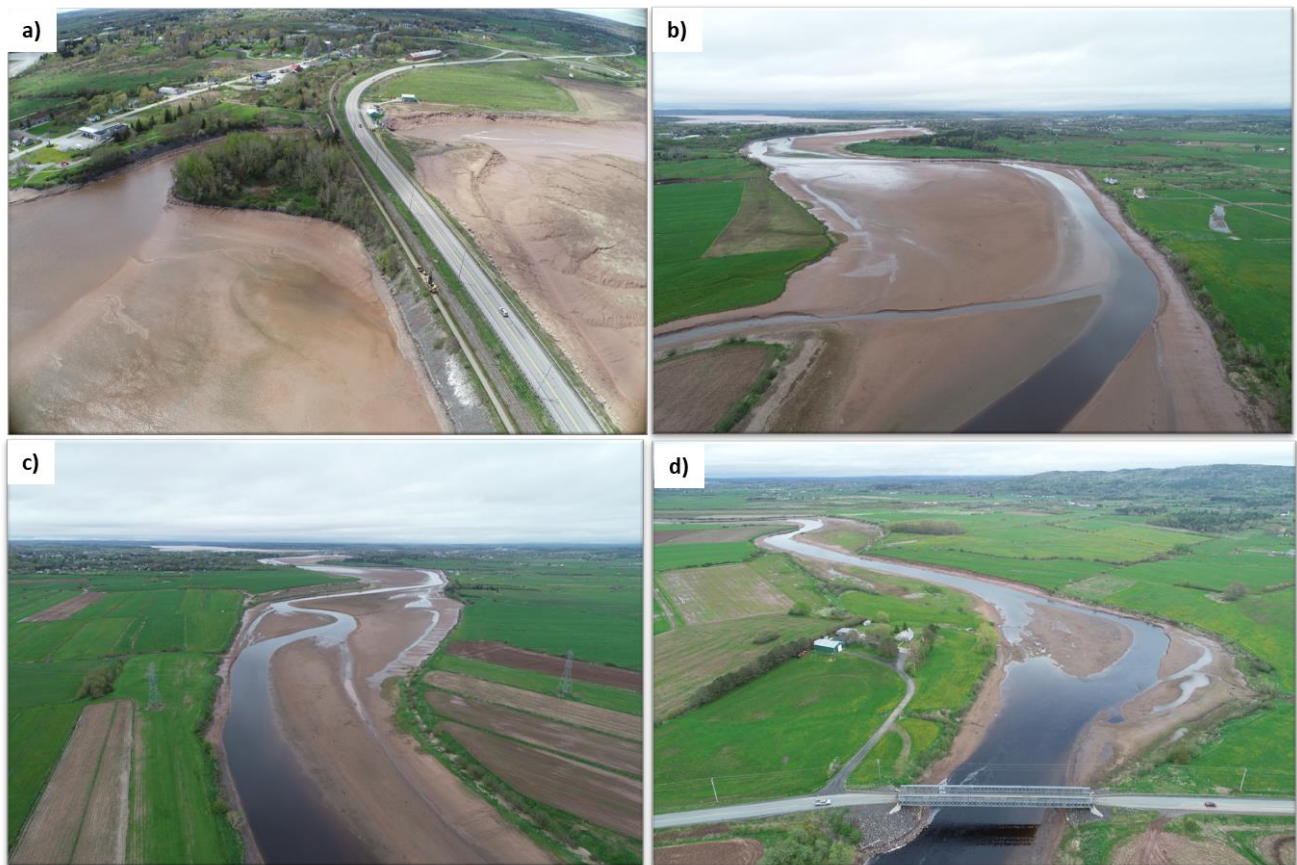
**FIGURE 9: LOW ALTITUDE OBLIQUE AERIAL IMAGERY TAKEN ON MAY 23, 2019 BY GREG BAKER WITH DJI PHANTOM 4 RTK RPAS, A) CAUSEWAY AND TIDE GATE; B) LOOKING NORTH (DOWNSTREAM) FROM ALLEN BROOK; PHOTOS TAKEN MAY 27, 2019 AT C) LOOKING NORTH FROM HV TRANSMISSION LINES AND D) LOOKING NORTH (DOWNSTREAM FROM SANGSTER'S BRIDGE).**

Low altitude aerial imagery collected on May 27, 2019 illustrate the presence of persistent bar features within the upstream river system and infilling adjacent to the causeway (Figure 9). In order to roughly correlate sedimentation and intertidal bar formation associated with gate openings, publicly available

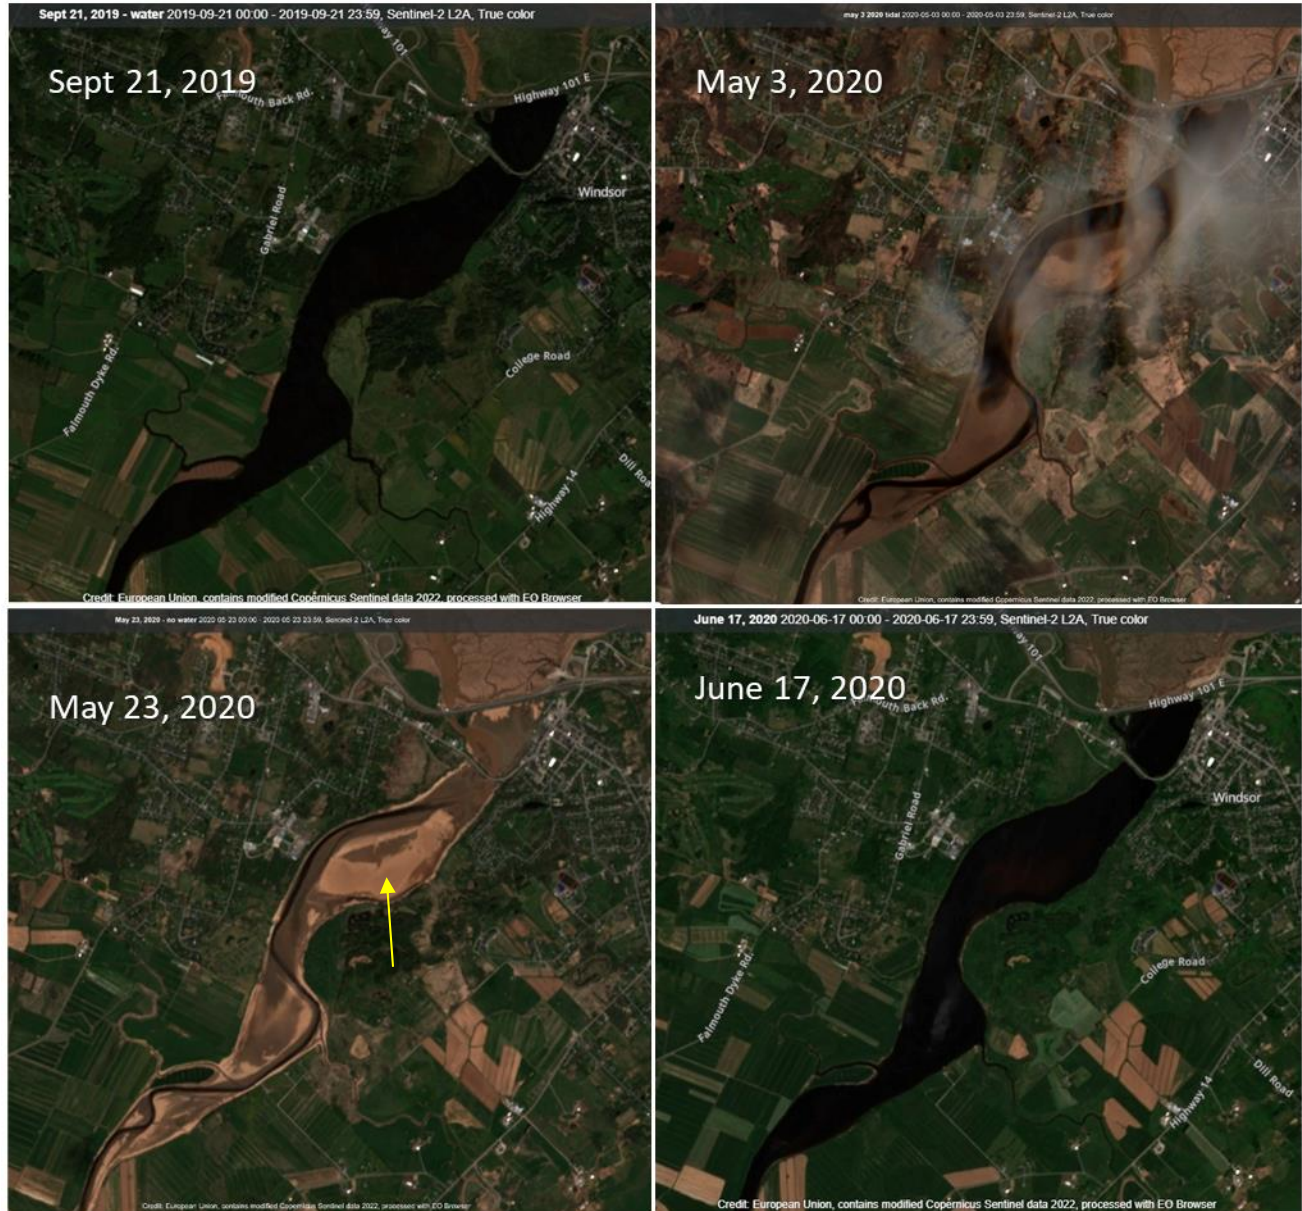
**FIGURE 10: COPERNICUS SENTINEL-2 SATELLITE IMAGERY ILLUSTRATING OPEN GATES AND TIDAL EXCHANGE IN MAY 2020. ARROW INDICATES INTERTIDAL BAR.**

The only period captured with less than 10% cloud cover between 2019-2020 where tidal waters are flowing upstream were May 3 and May 23, 2020 (Figure 10). Based on the bathymetric analysis, the intertidal bar indicated by the yellow arrow in Figure 10, has remained at the same elevation relative to datum since 1970. Using the measure tool within the EO Browser, the area of this deposited was estimated

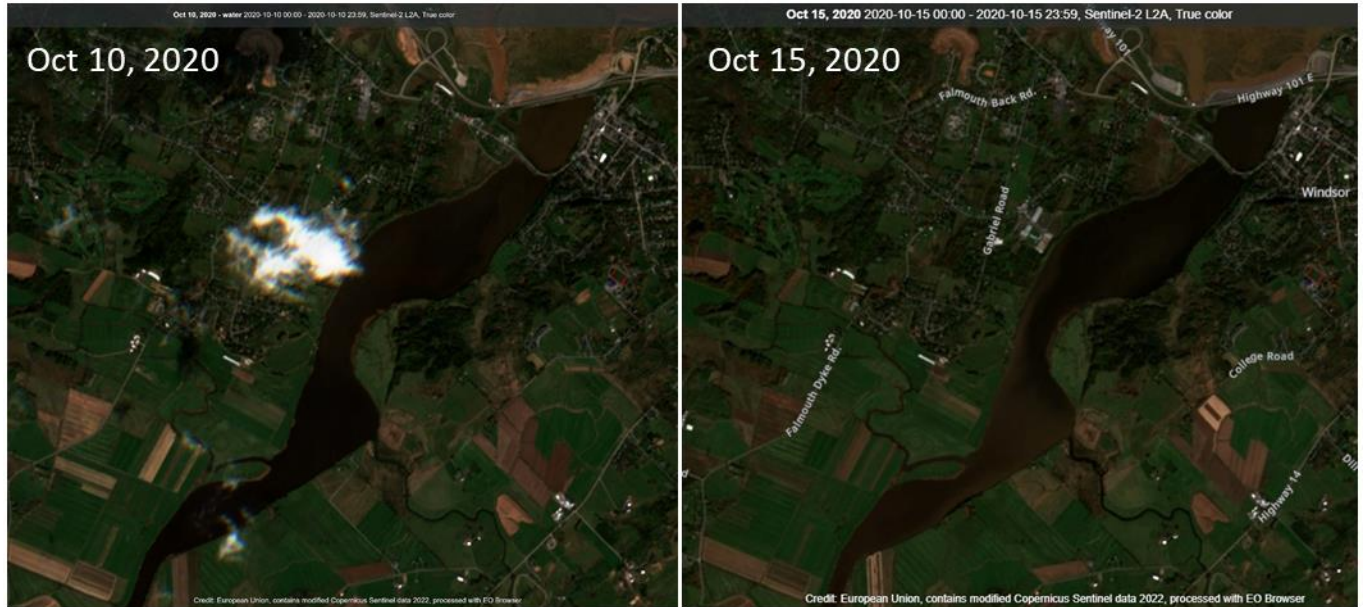
**FIGURE 11: SEDIMENT PLUME IN LAKE PISIQUID ON OCT 10, 2020, AND FURTHER UPSTREAM OCT 15, 2020.**

as 0.34 km<sup>2</sup>. Sediment laden waters are visible upstream and deposition in lake Pisiquid is visible on May 23, 2020 which is supported by the profile changes recorded during the bathymetric analysis (Figure 6a,b). In addition, a plume of sediment is observed within the Lake on Oct. 10, 2020 when gates appear to be closed (as evidenced by low tide and exposed saltmarsh downstream of the causeway). This plume is observed further upstream on Oct 15, 2020 (Figure 11).
