Ecomorphodynamics of the Avon River Upstream of the Windsor Causeway During Modified Gate Operations – Summer 2022

Nova Scotia Department of Public Works

CBWES Inc.

October 2023

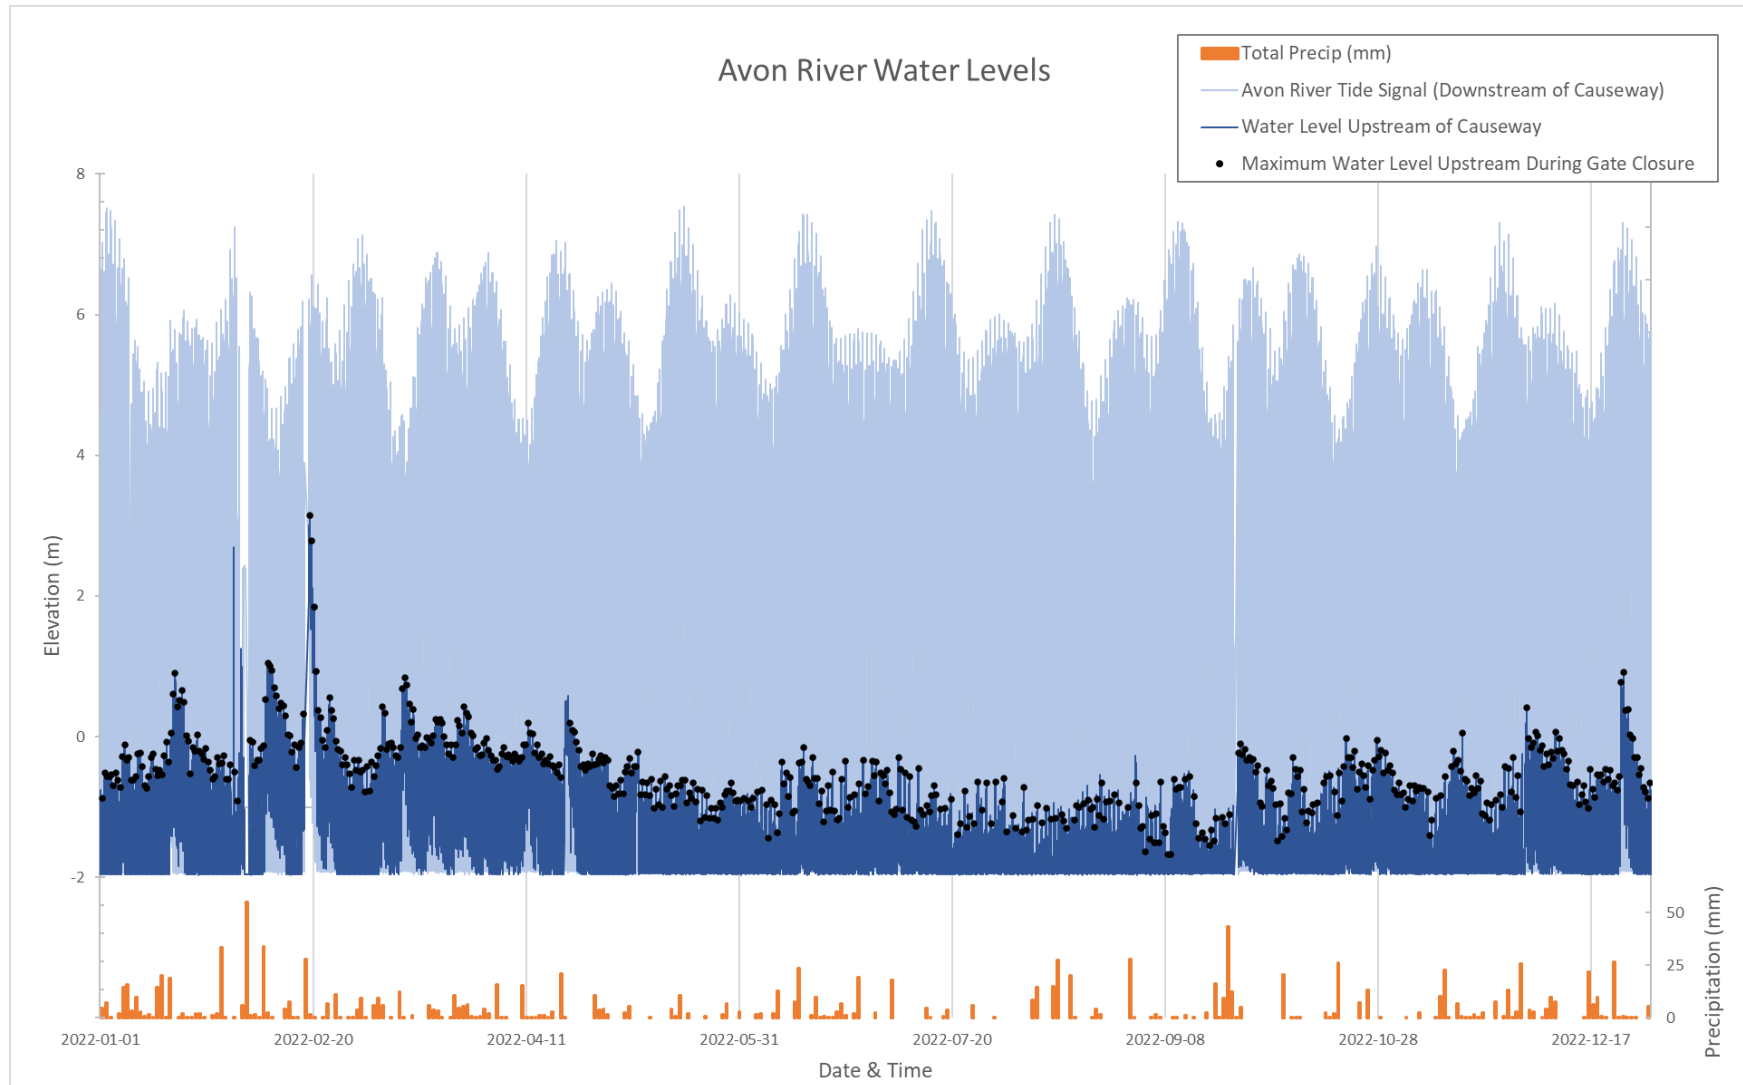
Figure 7: Tidal Signal for the High Tides of Avon River Upstream at the Highway 1 Bridge and Downstream of the Causeway in the Avon River within aboiteau 2021-2022; water level data courtesy of NSDA.

Water levels for the period of 1 January to 31 December 2022, are shown in Figure 7 with precipitation from the Kentville climate station⁴. Daily water fluctuations upstream of the causeway were most heavily influenced by the incoming tide, increasing rapidly until the tide gate was shut (Figure 8). The water levels then increase slowly as freshwater is not discharged during the high tide period. When the downstream tide levels fall to a level equal to the upstream water level, the tide gates are opened once again, and water levels drop both upstream and downstream. The average water level during the high tide period upstream of the aboiteau was $-0.57 \text{ m CGVD2013} \pm 0.54 \text{ m}$, while downstream it was $5.8 \text{ m CGVD2013} \pm 0.79 \text{ m}$.

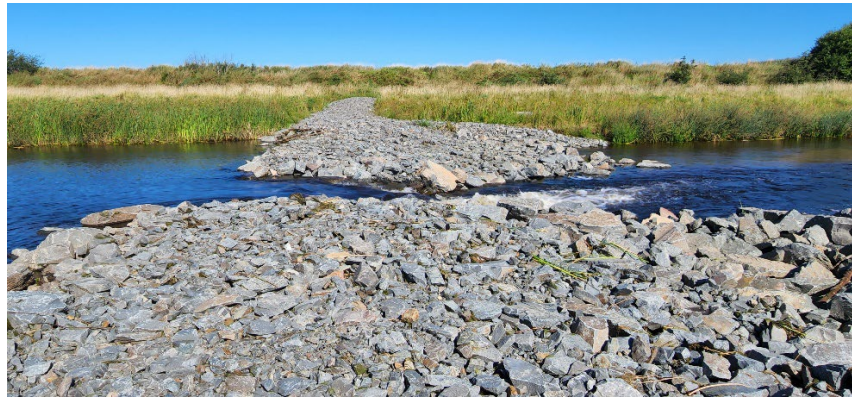
Figure 15: Martock fish habitat offsetting project - partial dam near T7–T8.

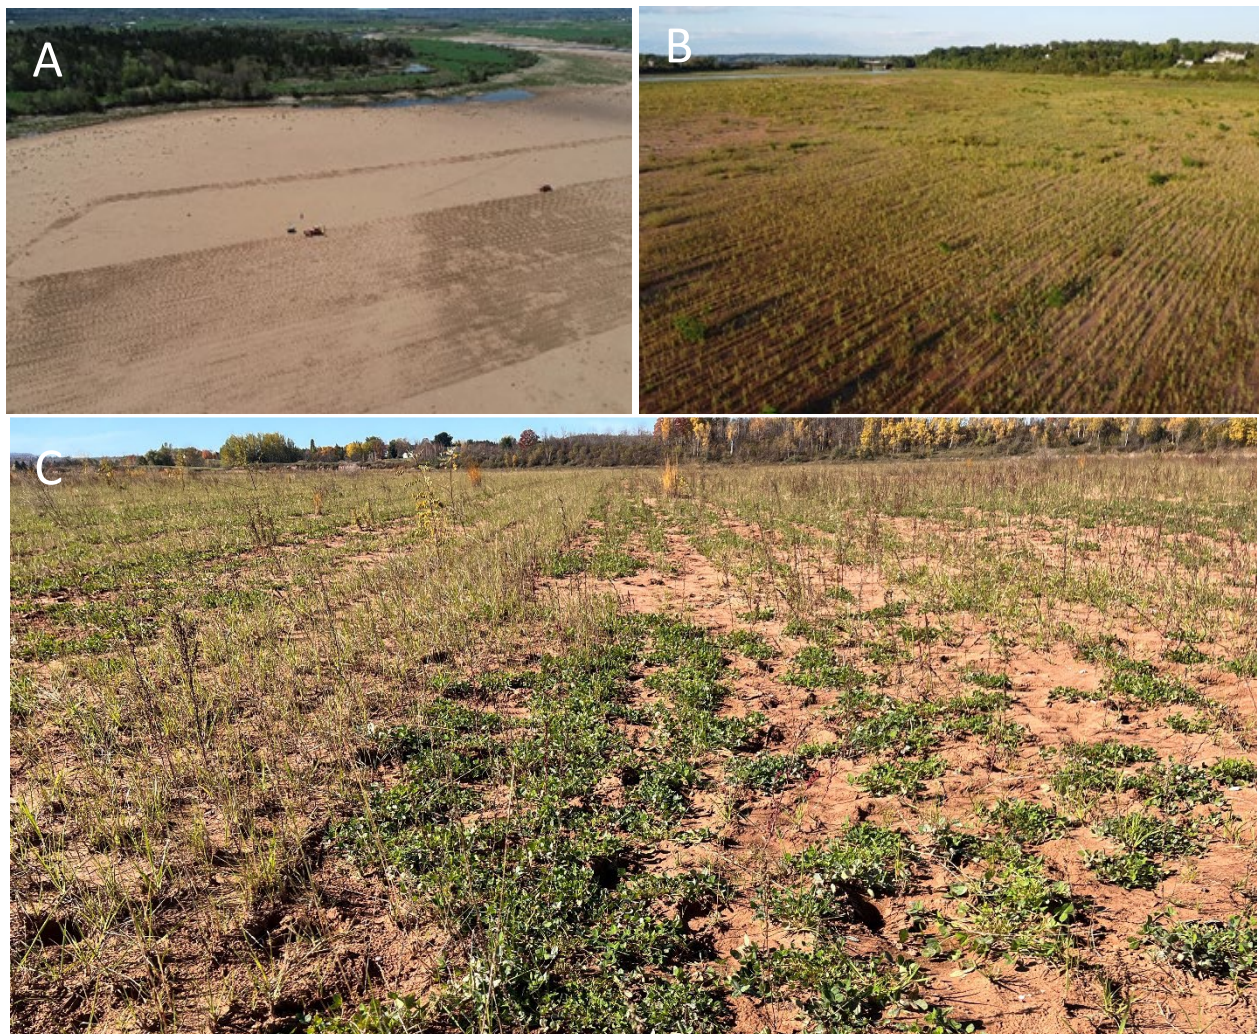
Figure 16: The progress of the Windsor Sandbar Seeding Project from A) the planting of the highway seed mix using two tractors and a side-by-side on 13 May 2022, to B) the growth of the planted seeds on 1 September 2022, C) Planting with colonization by weedy ruderals and horse tracks 28 October 2023. Photo A credit: Graeme Matheson (NSDA); photo B credit: Nikki-Marie Lloyd (CMM); photo C: CBWES Inc.

Though data was not collected, early observations of colonization of the mudflat indicated halophytes such as *Sporobolus alterniflorus* to be the most prominent species in the first year of growth. In 2022, while halophytes were still abundant at 23% coverage, freshwater wetland species and weedy ruderals made up the majority of vegetation species found in the study site. The area where the seeding project was carried out remained sparse when compared to other areas, but was showing clear signs of growth in areas where seed was planted (Figure 12). Oblique imagery captured during the drone flight in September show clear growth of grass species in rows as per the planting efforts in May (Figure 16a,b). In some areas natural colonization seemed to also be occurring overtop of seeding, as evident both in aerial imagery and in photos captured on the ground in October (Figure 16c).

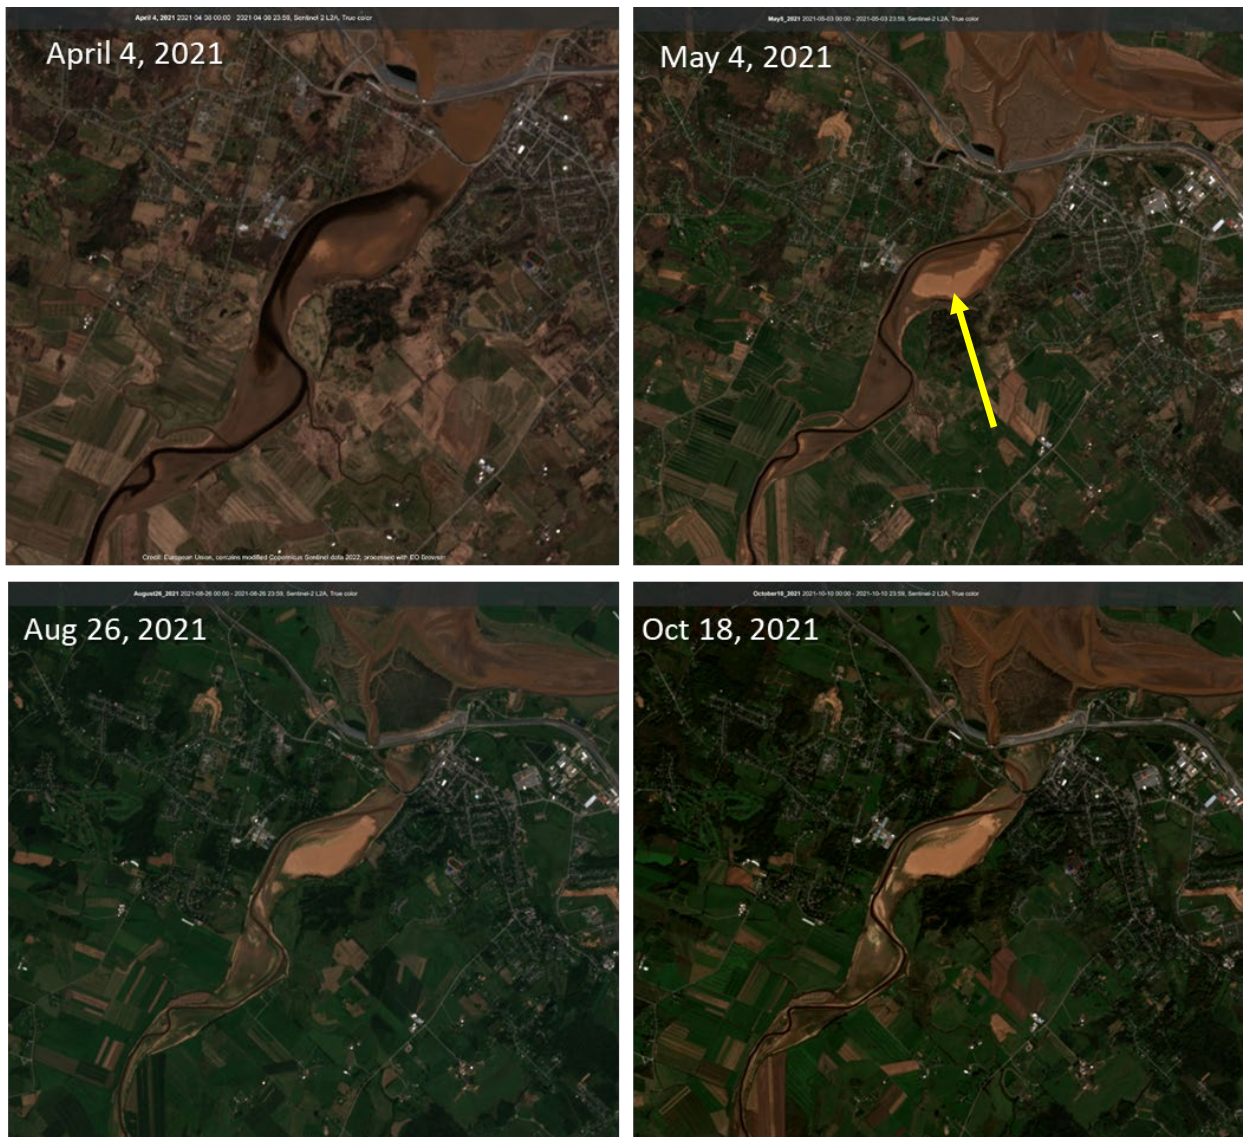
Figure 17: Copernicus Sentinel-2 satellite imagery (April – October 2021) illustrating sedimentation and evolution of intertidal bar and wetland vegetation after gates opened to allow for fish passage in March 2021. Arrow indicates position of sand bar and site of dust mitigation efforts.

to remain stable from April 2021 to February 2023 (Figure 17, Figure 18, Figure 19). Vegetation and algae growth are evident in the available 26 August 2021 imagery (Figure 17).

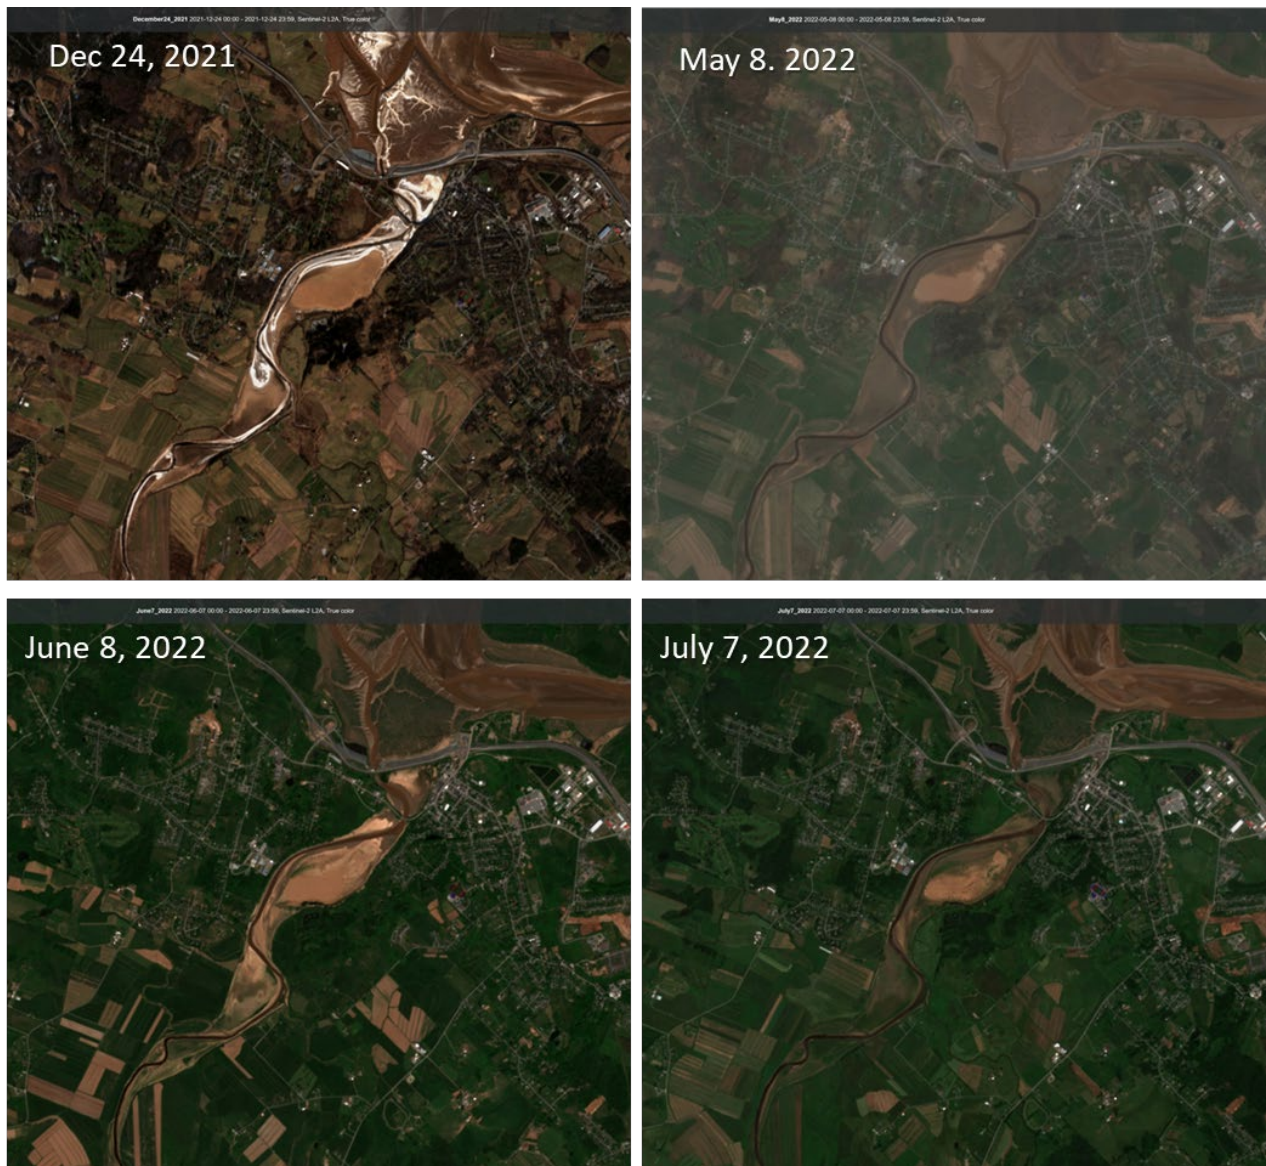
Figure 18: Copernicus Sentinel-2 satellite imagery (December 2021 – July 2022) illustrating sedimentation and evolution of intertidal bar and wetland vegetation after gates opened to allow for fish passage in March 2021.

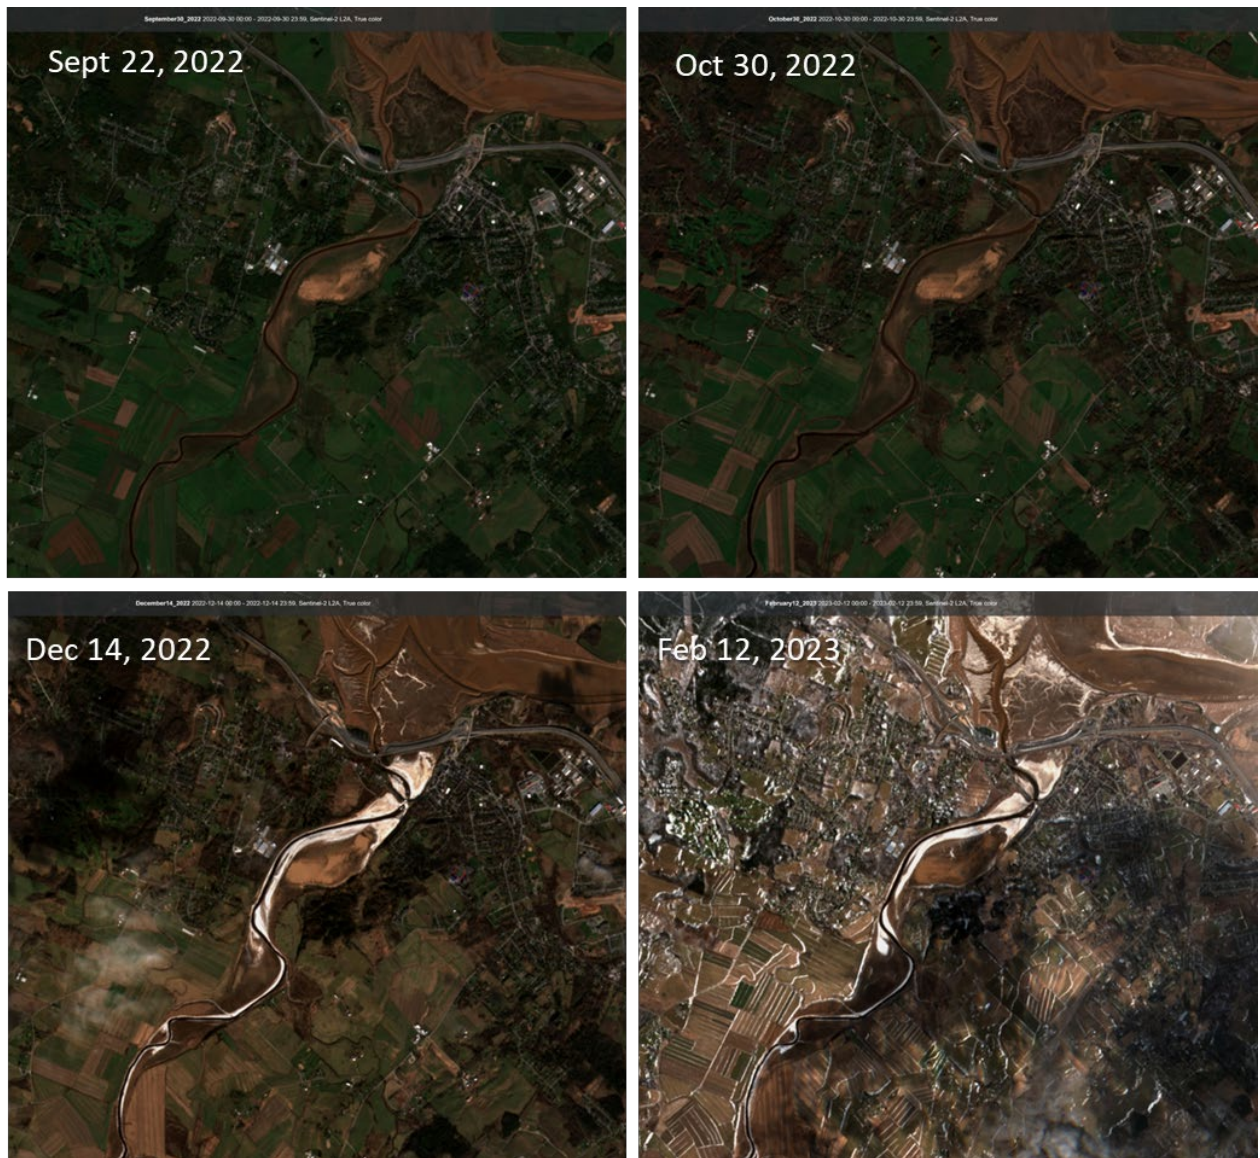
Figure 19: Copernicus Sentinel-2 satellite imagery (September 2022–February 2023) illustrating sedimentation and evolution of intertidal bar and wetland vegetation after gates opened to allow for fish passage in March 2021.

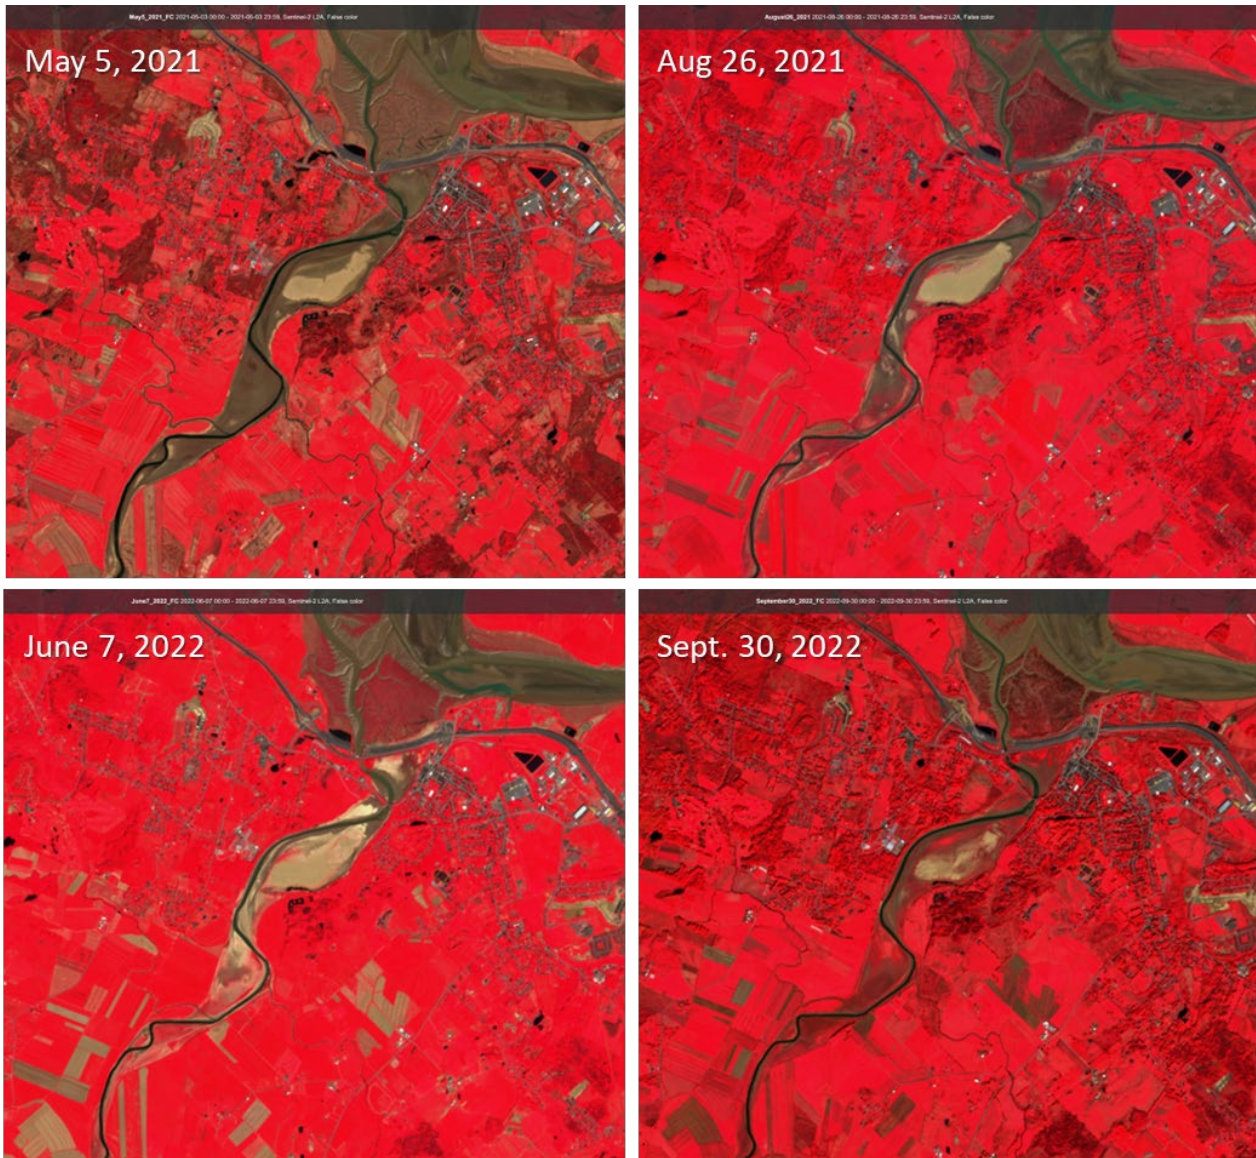
Figure 20: Copernicus Sentinel-2 imagery displayed as false color bands 8, 4, 3 illustrating vegetation growth on intertidal flats upstream of causeway from 5 May 2021 to 30 September 2022.

A false color composite of the Sentinel-2 imagery using near infrared, red and green bands can be used to assess plant density since plants reflect near infrared and green light while they absorb red. Therefore, areas in red indicate vegetation growth but not the type of vegetation. Figure 20 illustrates the expansion of vegetation between 5 May 2021 and 30 September 2022 and the marked reduction of bare ground. This supports the transect vegetation station findings reported in Section 5. While areas of the large sand bar are slowly being vegetated, bare areas of sand remain. Overall, the system is behaving as expected with even partial re-introduction of tidal flow. Quantifying changes in bathymetry and sediment volume are not possible within this report due to poor weather conditions and lack availability of survey equipment prior to winter.

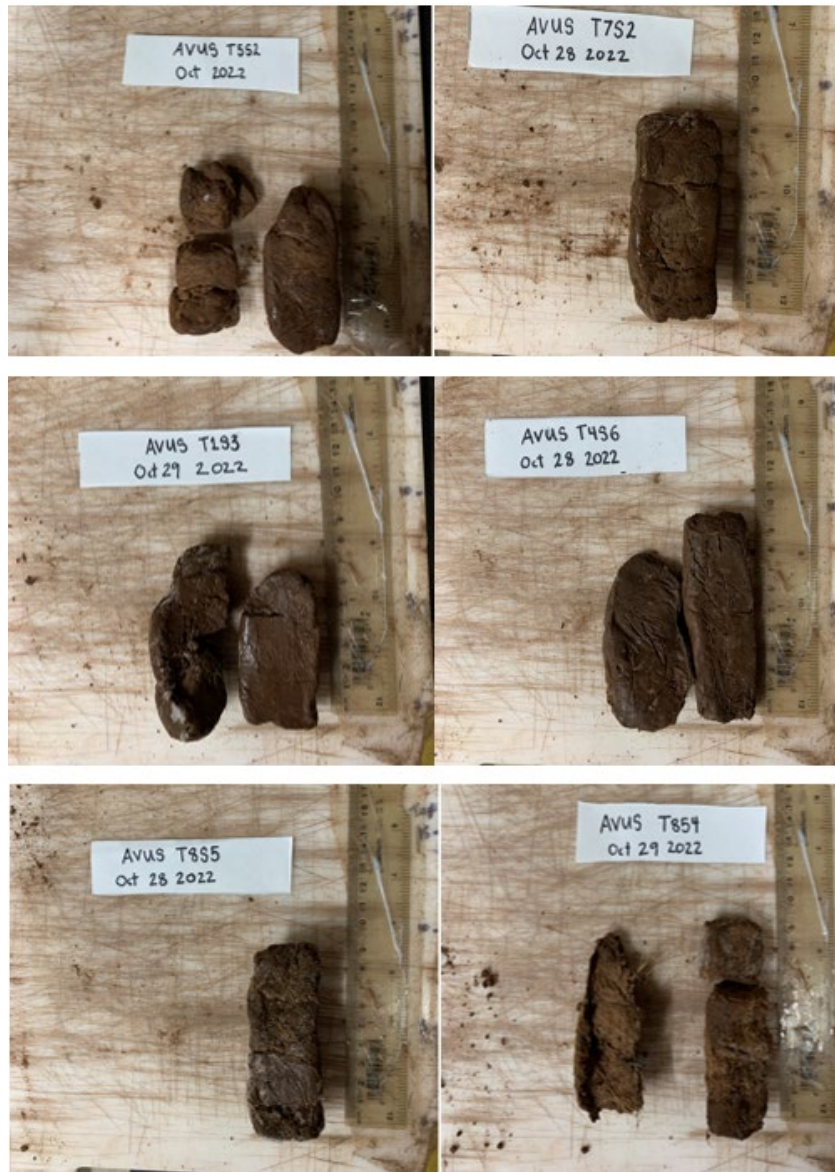
Figure 22: Sample of sediment cores processed in winter 2023.

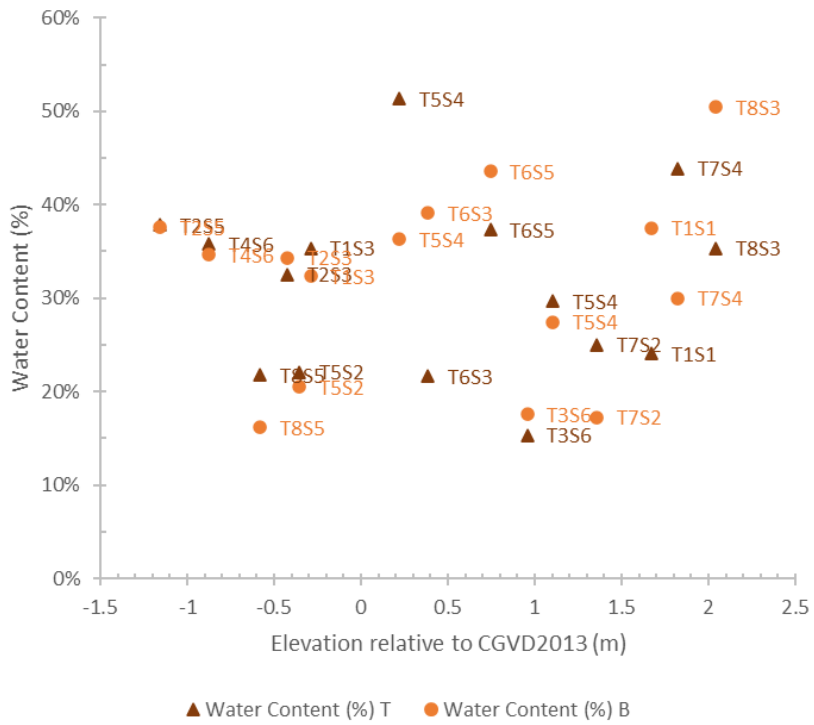
Figure 23: Water content of the core samples taken from the top and bottom 2 cm of each core in percent, versus the elevation in meters.

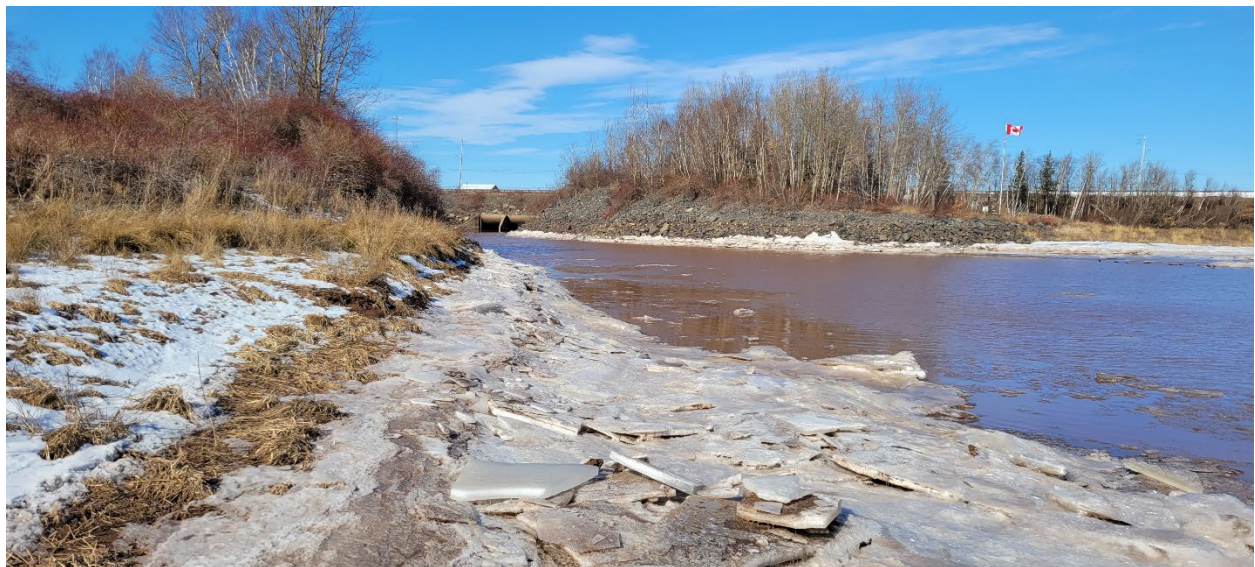
Figure 30: Ice slabs on the banks of the Avon River, 9 February 2023.

During the walk there was partial snow and ice coverage (Figure 29). Broken ice slabs were visible along the banks of the Avon River upstream of the tide gates (Figure 30).

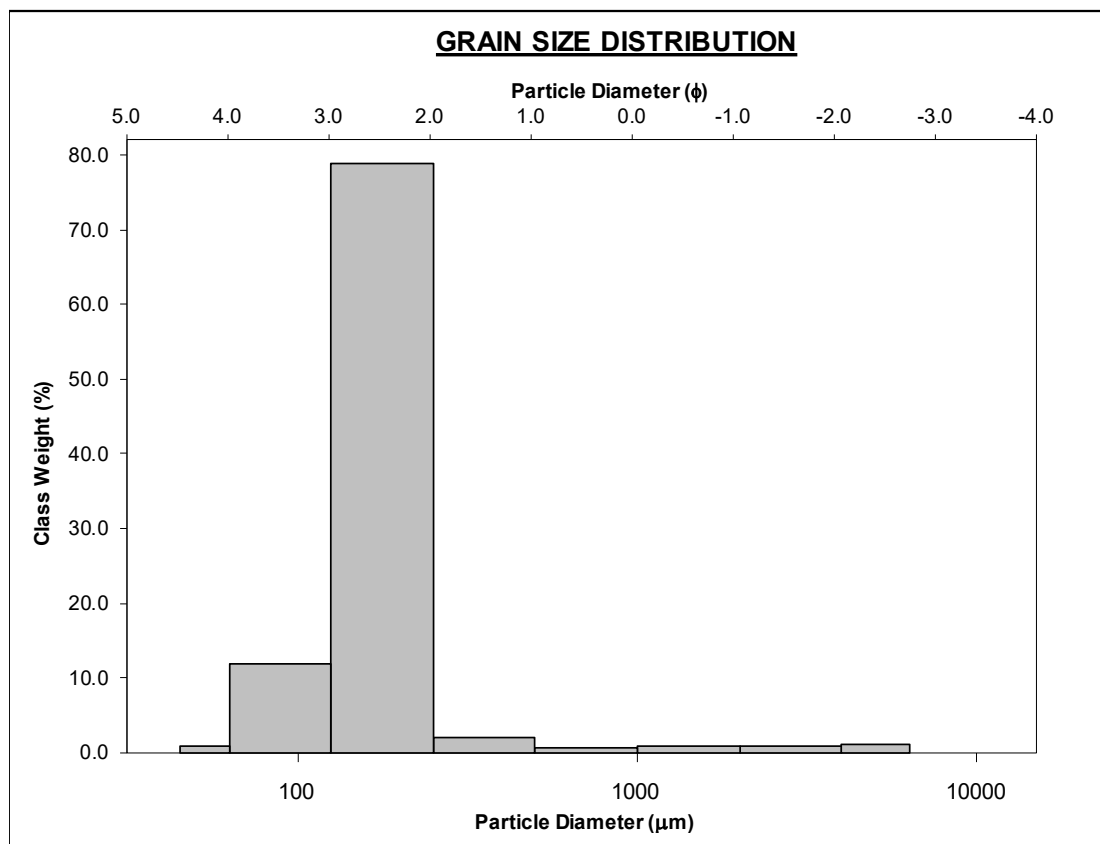
SAMPLE STATISTICS				
SIEVING ERROR: 0.0%						
SAMPLE IDENTITY: BW_54		ANALYST & DATE: Leila Rashid, 28/10/2022				
SAMPLE TYPE: Unimodal, Moderately Well Sorted		TEXTURAL GROUP: Slightly Gravelly Sand				
SEDIMENT NAME: Slightly Very Fine Gravelly Fine Sand						
				GRAIN SIZE DISTRIBUTION		
	μm	ϕ				
MODE 1:	187.5	2.500	GRAVEL: 1.7%	COARSE SAND: 0.9%		
MODE 2:			SAND: 97.1%	MEDIUM SAND: 2.2%		
MODE 3:			MUD: 1.2%	FINE SAND: 80.9%		
D ₁₀ :	103.2	2.053		V FINE SAND: 12.2%		
MEDIAN or D ₅₀ :	171.0	2.548	V COARSE GRAVEL: 0.0%	V COARSE SILT: 0.6%		
D ₉₀ :	241.0	3.276	COARSE GRAVEL: 0.0%	COARSE SILT: 0.1%		
(D ₉₀ / D ₁₀):	2.334	1.596	MEDIUM GRAVEL: 0.0%	MEDIUM SILT: 0.1%		
(D ₉₀ - D ₁₀):	137.8	1.223	FINE GRAVEL: 0.8%	FINE SILT: 0.1%		
(D ₇₅ / D ₂₅):	1.535	1.276	V FINE GRAVEL: 0.9%	V FINE SILT: 0.1%		
(D ₇₅ - D ₂₅):	73.87	0.618	V COARSE SAND: 1.0%	CLAY: 0.1%		
		METHOD OF MOMENTS		FOLK & WARD METHOD		
	Arithmetic	Geometric	Logarithmic	Geometric	Logarithmic	Description

μm	μm	ϕ	μm	ϕ	
MEAN (\bar{x}):	259.5	174.3	2.520	171.0	2.548	Fine Sand
SORTING (σ):	525.5	1.825	0.868	1.428	0.514	Moderately Well Sorted
SKEWNESS (S_k):	7.557	1.502	-1.502	-0.064	0.064	Symmetrical
KURTOSIS (K):	64.11	19.42	19.42	1.331	1.331	Leptokurtic
