Monitoring Seasonal Changes in Surface Elevation of Intertidal Environments near the Windsor Causeway

Dr. Danika van Proosdij Department of Geography

May 18, 2005

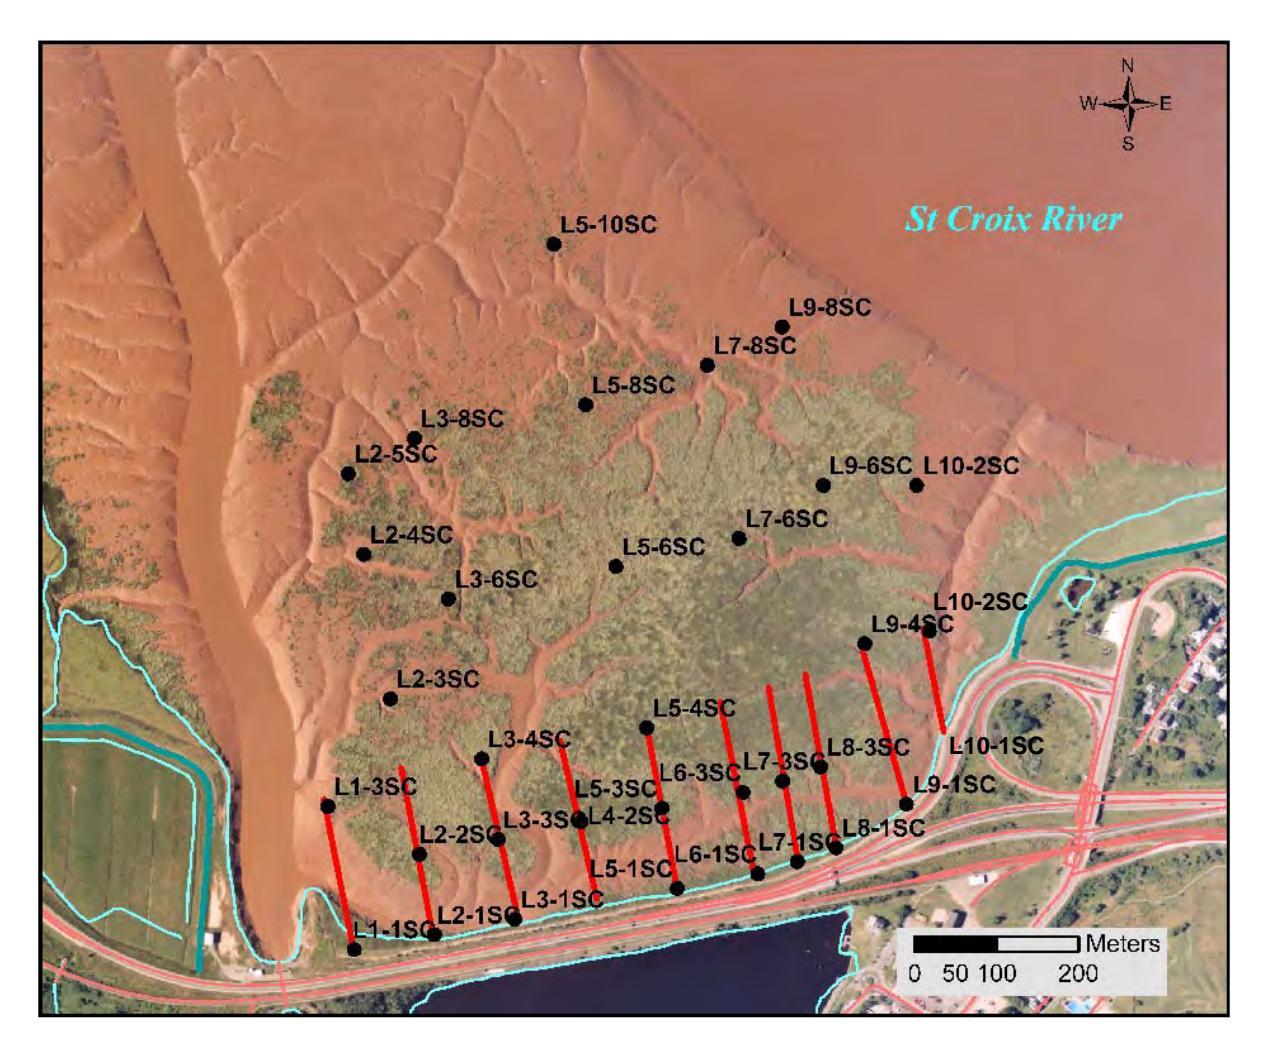
Figure 1: Location of sampling lines over 2003 aerial photograph. Topographic survey lines indicated in red.

Changes in surface elevation were measured as the depth to buried aluminum plates along existing transects within the salt marsh-mudflat system (Figure 1). These data were recorded in June and November to quantify changes in surface elevation during the winter/spring, summer and fall. The locations of all stations have previously been recorded using a differential GPS system (van Proosdij *et al.*, 2004; Daborn *et al.*, 2003). These data were entered into ArcView 8.3 and used to create a preliminary interpolated surface of change in surface elevation. However, given the number and arrangement of the 14 plates which survived the winter, the modeled interpolated surface would not be truly representative of processes operating within the main marsh body or the edges of the tidal creek. Therefore, these data will be provided in tabular and graphical form only. In addition, the spatial pattern of plate survival will be addressed within the winter section of the results and an assessment of the feasibility of continuing with plate monitoring will be provided.

Detailed topographic surveys along existing lines (Figure 1) were conducted using a Leica TCR Reflectorless Total Station set relative to a known geodetic benchmark in June, 2004. This instrument has a precision of 2 mm. However, given the difficulty of surveying within this unconsolidated environment, survey results will likely only be accurate to \pm 5 cm. All elevations are expressed as orthometric heights relative to datum (CGVD28) using the HTv2 geoid model. Additional shorter surveys were conducted perpendicular to the causeway over a distance of 200 m in November, 2004. These cross sectional profiles were analyzed using Excel and incorporated into ArcView 8.3 and associated extensions to derive volumetric estimates of sediment deposition and erosion. In addition, winter sediment dynamics (such as movement of ice floes and vegetated root mats) were observed using digital photography and/or direct field observation.

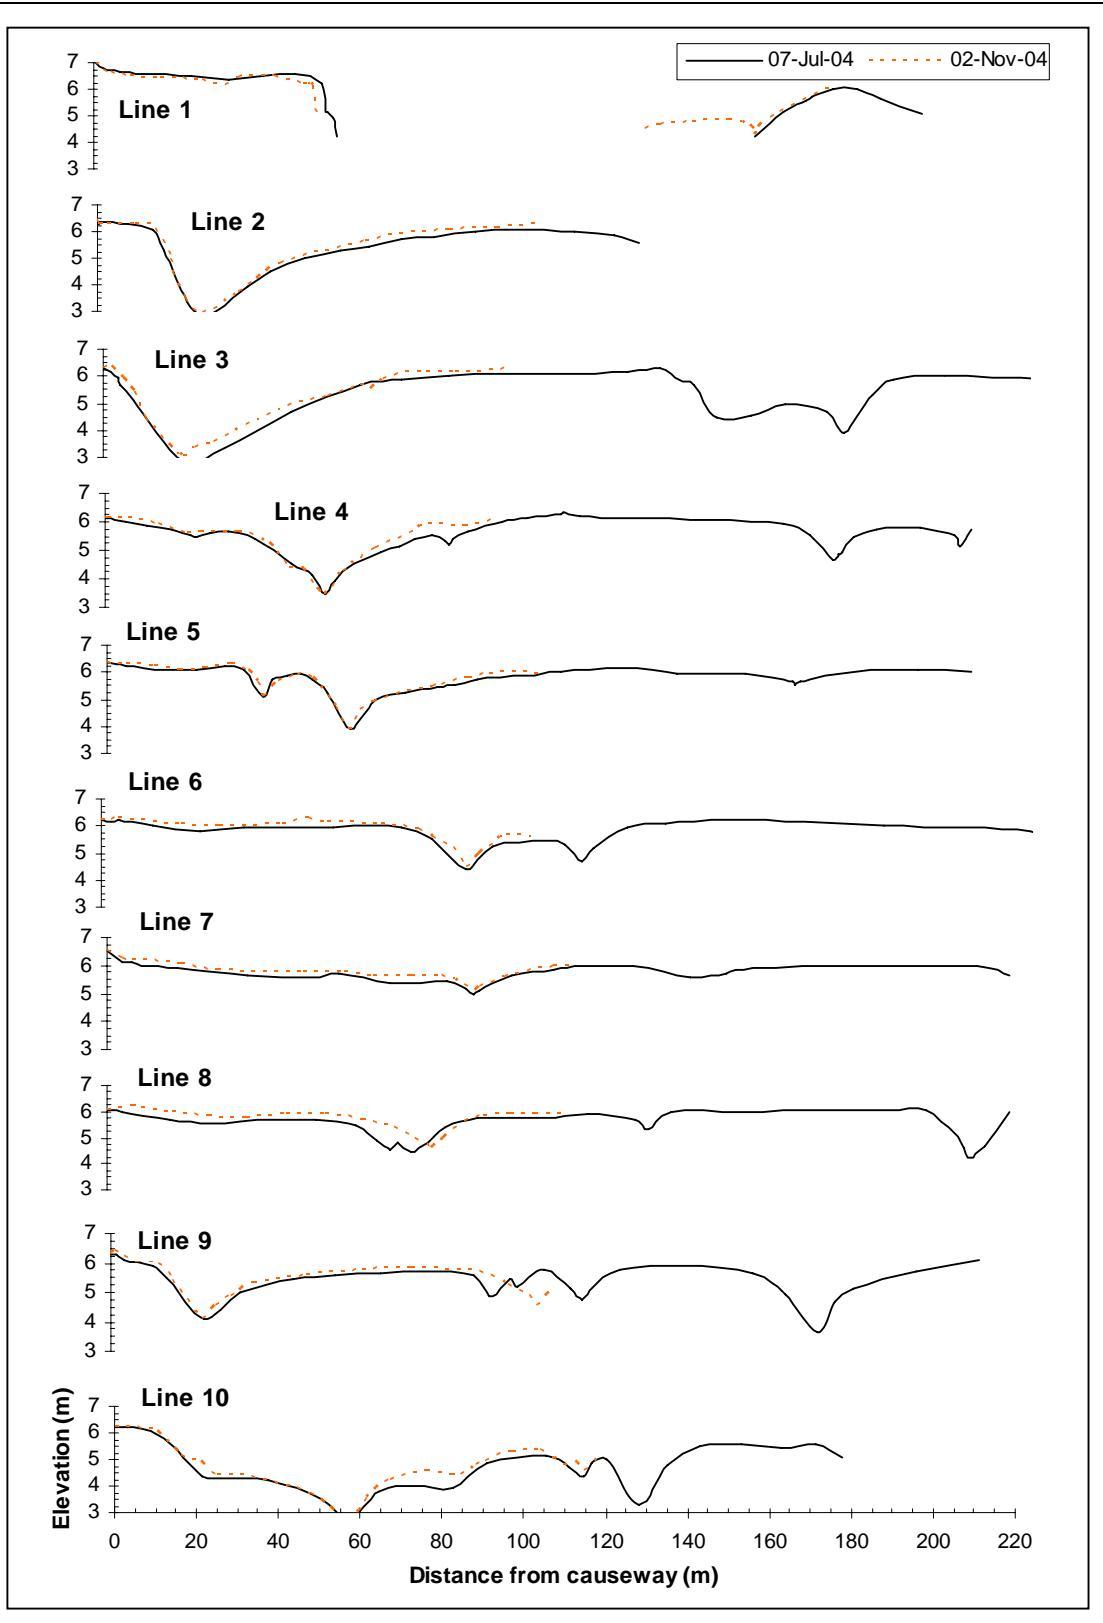
Figure 2: Comparison of topographic profiles surveyed in June and November 2004. Distance measured from base of causeway on marsh surface. Elevation is measured relative to MSL as defined by the CGVD28 datum.

(Table 1). The net change along all lines is positive suggesting an additional source of sediment, and although sediment is eroded in sections (Figure 2), this material is likely deposited within the immediate area.

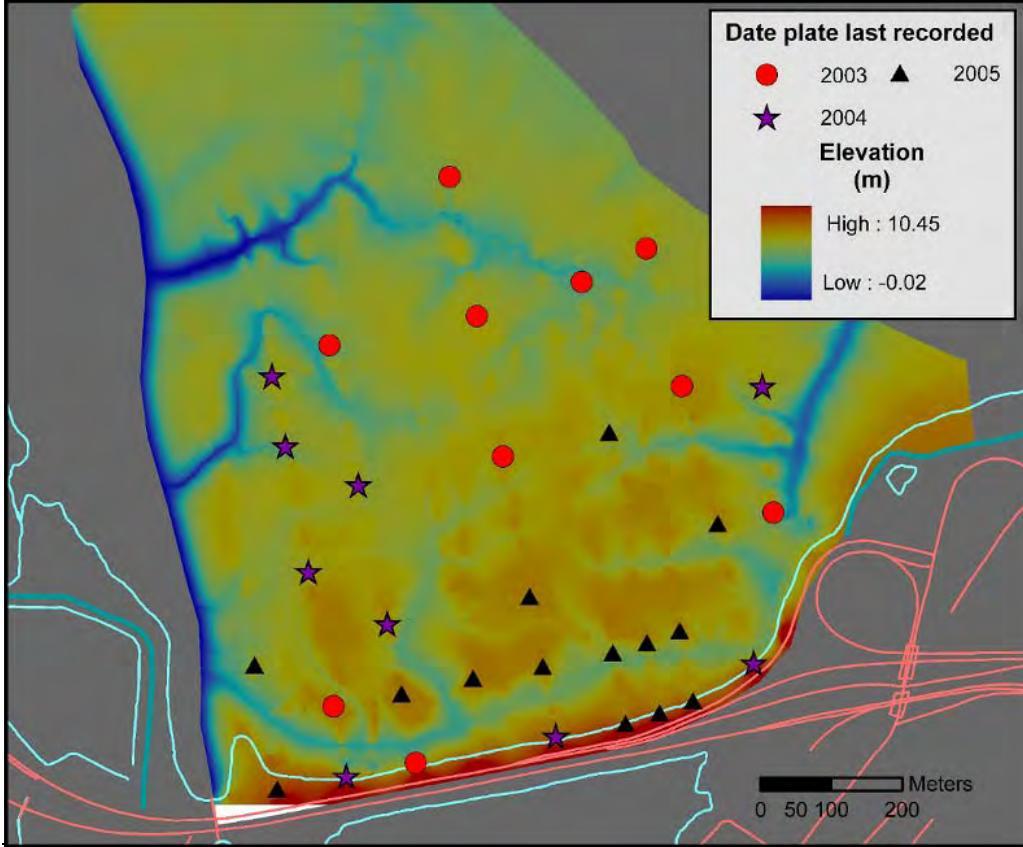
Figure 3: Map indicating 'survival' of plate stations over Winter 2002-03, 2003-04 and 2004-05. A total of 9 plates were lost in 2002-03, 9 in 2003-04 and one in 2004-05. Points are draped over digital elevation model developed by G. Baker in 2004 using TopoGrid command in ArcInfo. Fifteen plates were reinstalled during the summer of 2005.

A total of fourteen plate stations were able to be measured in June 2004. Nine plates were not able to be re-located most likely due to ice scour and plucking as evidenced by marks remaining on the marsh / mudflat surface. These were located primarily along lines 2 and 3 near the Avon River channel and line 10 (Figure 3). The exceptions are L5-1sc and L9-1sc which likely are buried to a depth greater than the measuring rod as evidenced by the thick layer of sediment over top of the vegetation.

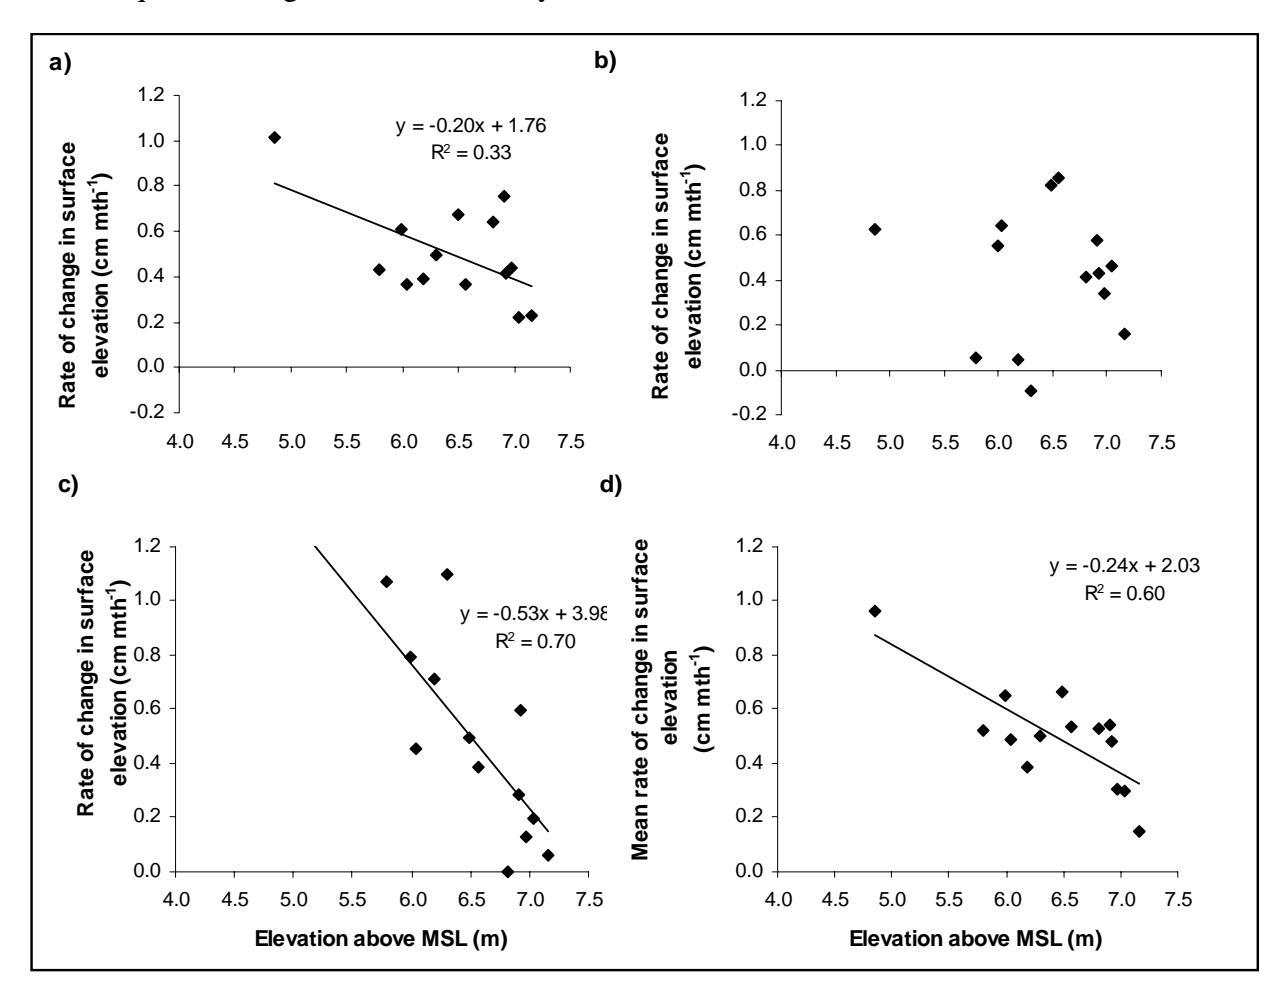
Figure 4: Rate of change in surface elevation in relation to elevation of the station location above sea level from a) May 7, 2003 to June 8, 2004 ; b) June 8 to November 23, 2004 and c) November 23, 2004 to May 2005. The mean rate of change in surface elevation from 2003 to 2005 is presented in d. MSL = mean sea level relative to the CGVD28 vertical datum.

In general, one might be able to discern a decreasing trend in the rate of change in surface elevation with increasing elevation (Figure 4) but this trend is only strong over the November 2004 to May 2005 period and does also appear if the mean data are presented. Additional data are required for a complete statistical analysis. The literature supports a general decrease in sedimentation with increasing marsh elevation due to decreased frequency in tidal flooding. However, other studies conducted in the Bay of Fundy (e.g. van Proosdij *et al.*, in press; Davidson-Arnott *et al.*, 2002) demonstrate that frequency of inundation does not necessarily entrain higher sedimentation rates due to the impact of waves. In the current study, all of the sample stations are sheltered from wave activity, likely facilitating higher sedimentation rates. The sites however would be exposed to higher amounts of suspended sediment to be deposited (van Proosdij *et al.*, 2001). This sediment would then be expected to be deposited within the quiescent region of the causeway channel.

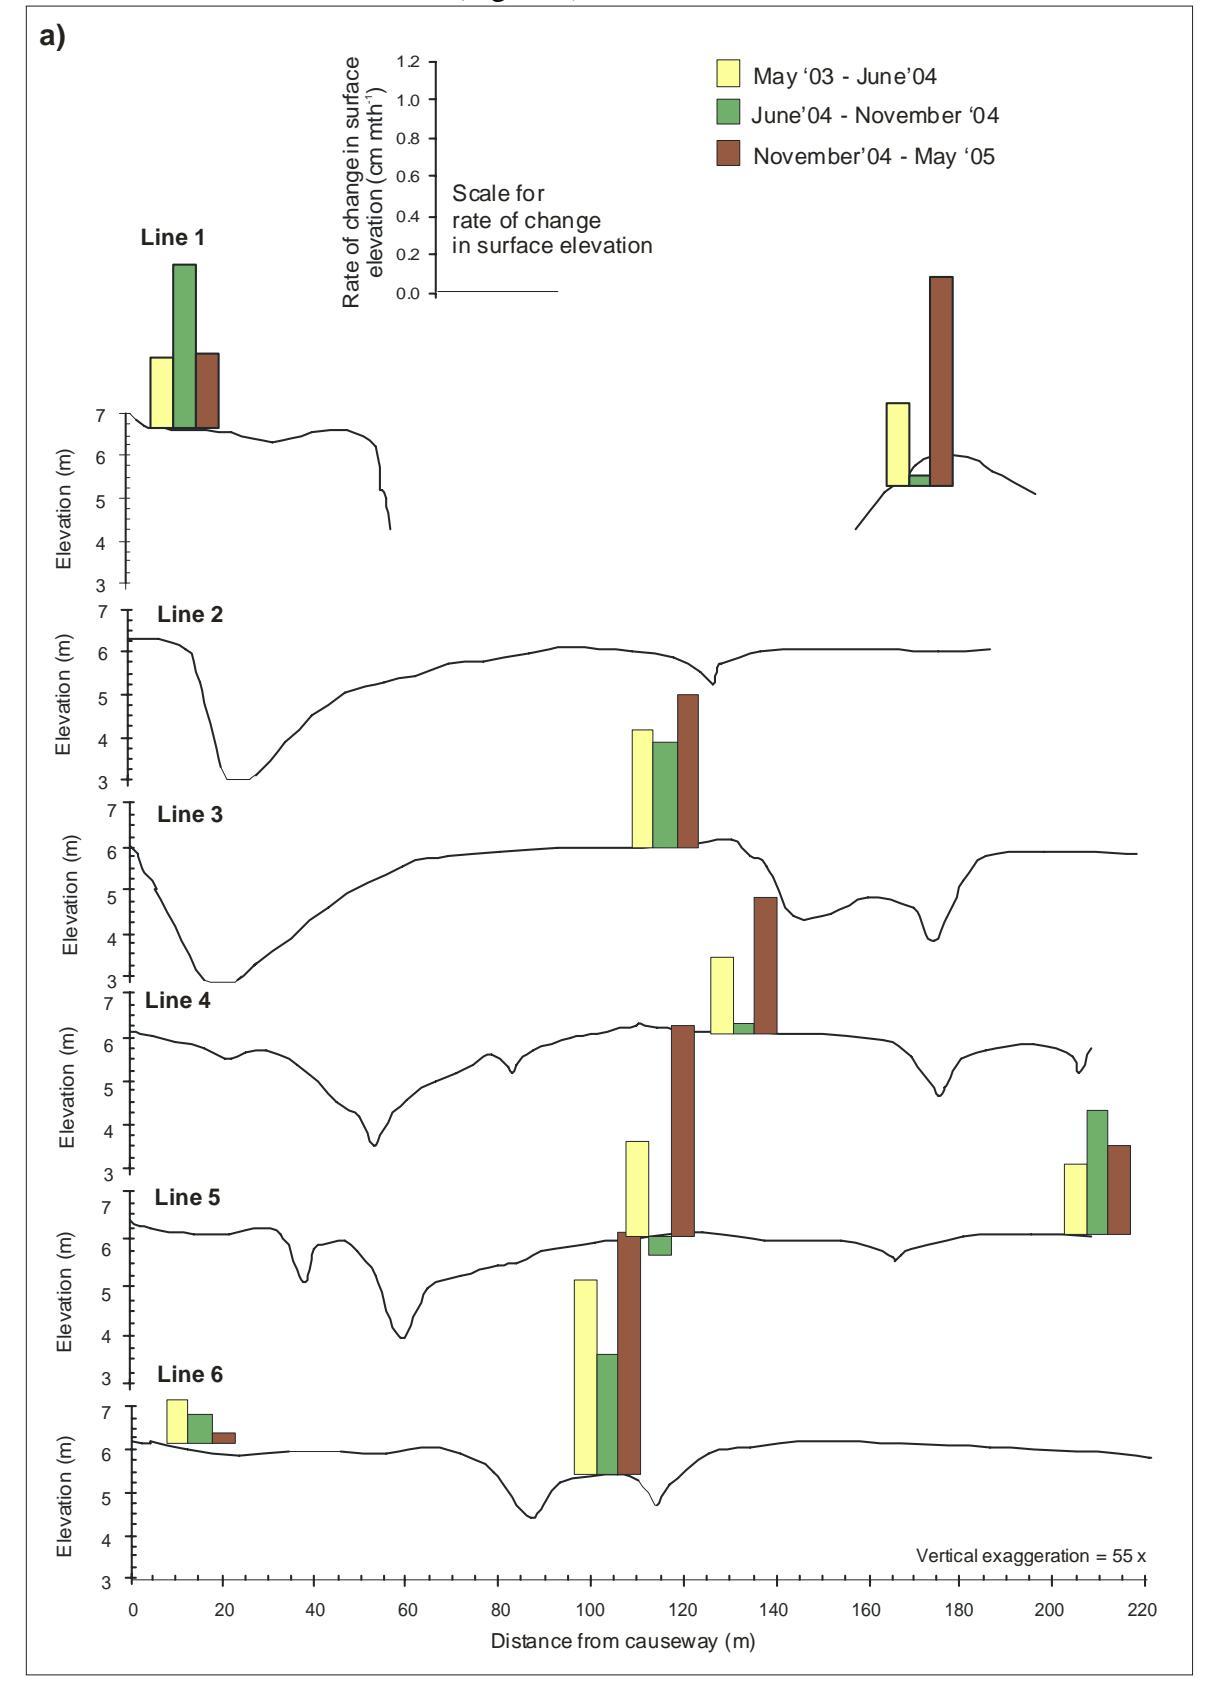
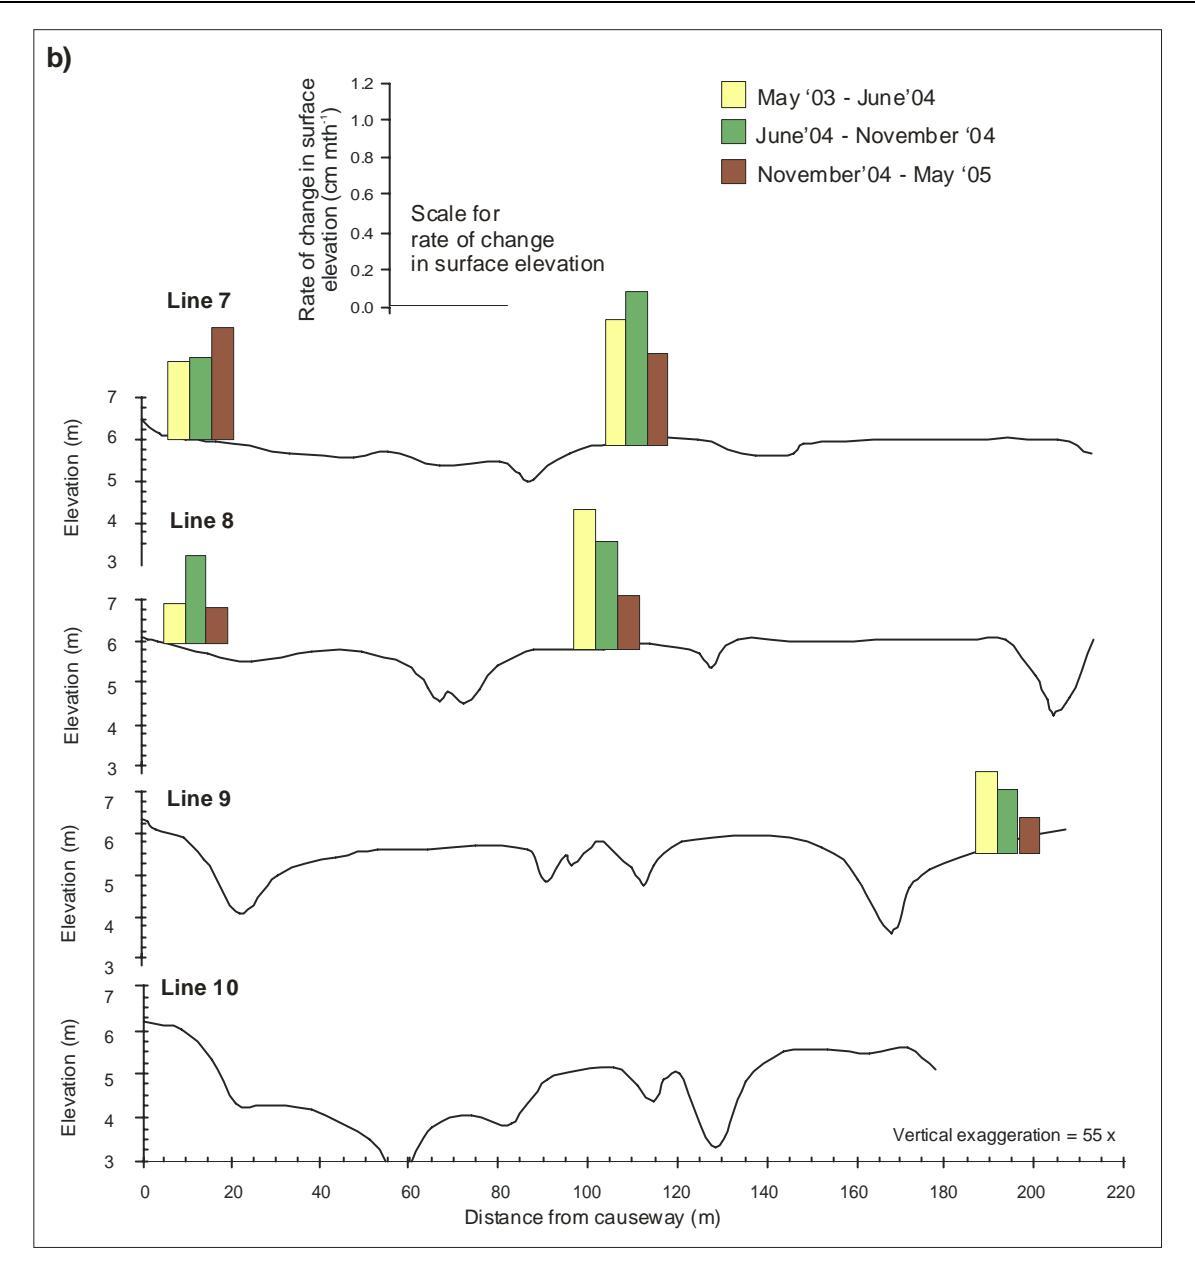
Figure 5: Rate of change in surface elevation at plate stations which survived the winter season. Topographic profiles are presented from the June 2004 survey for a) lines 1 to 6 and b) lines 7 to 10. Distance measured from base of causeway on marsh surface. Elevation is measured relative to MSL as defined by the CGVD28 datum. Depth of channel at line 1 not surveyed due to dangerous, unconsolidated nature of mudflat surface.

In order to examine the spatial patterns of sedimentation along the causeway channel, surface elevation change data were plotted over topographic profiles surveyed in June, 2004 (Figure 5). In general, there is a greater rate of change over the winter season for most lines except L8 and L9. This may be

attributed to a decrease in flooding frequency as the eastern section of the causeway channel continues to infill. Alternatively it might reflect a shift in the position of the creek channel thalweg and associated creek bank on Lines 8 and 9 (Figure 6).

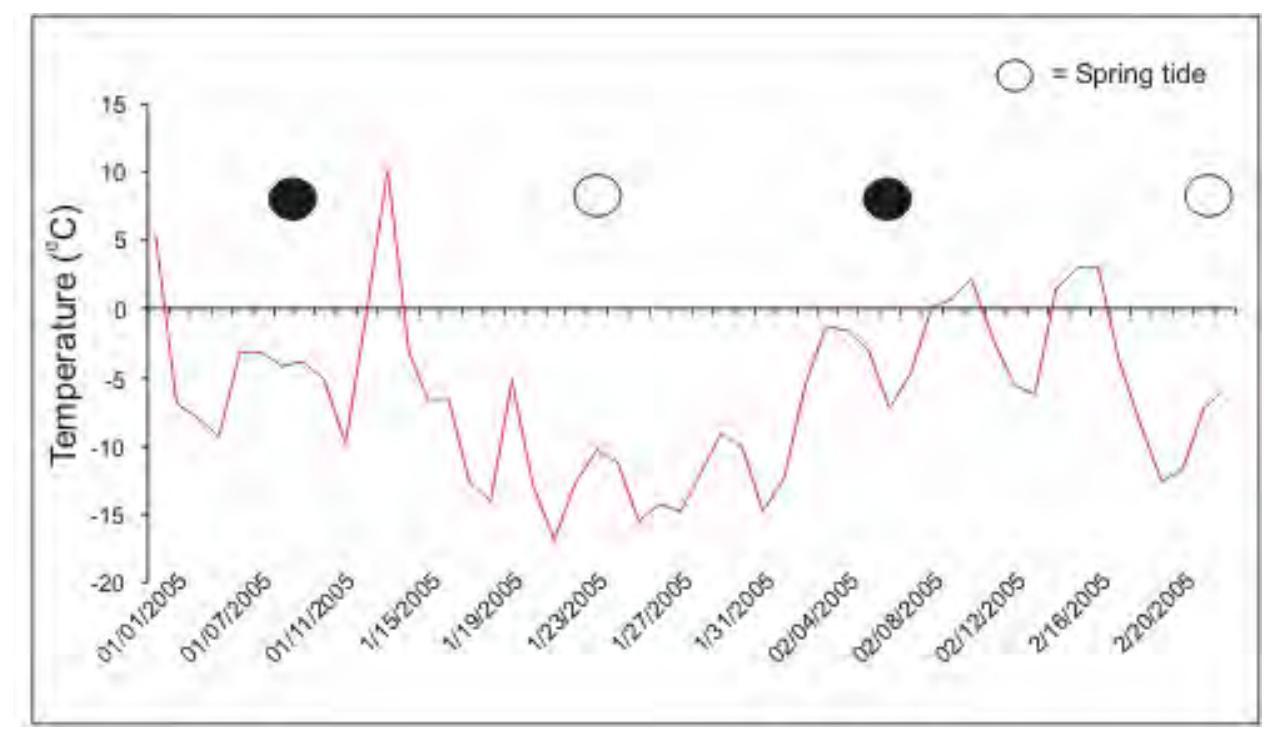
Figure 6: Temperature recorded at the Weatherhawk weather station at the Windsor tide gate for winter study and timing of spring tidal cycle. Filled and open circles represent old and new moons respectively.

In early January, small amounts of ice were observed by Ken Carroll (NSDAF) at the Windsor tide gate forming in the tidal creek channels during neap tides. By January 10, ice blocks were observed scattered over the marsh surface however strong NW winds moved ice off of the salt marsh surface during the high spring tides that night (Figure 6).

After February 17th, mean temperatures dropped significantly (Figure 6), freezing ice blocks to the marsh and mudflat surface (Figure 11). Subsequent spring tides with any wave action would have the potential to rip out marsh vegetation and their roots (Figure 12).

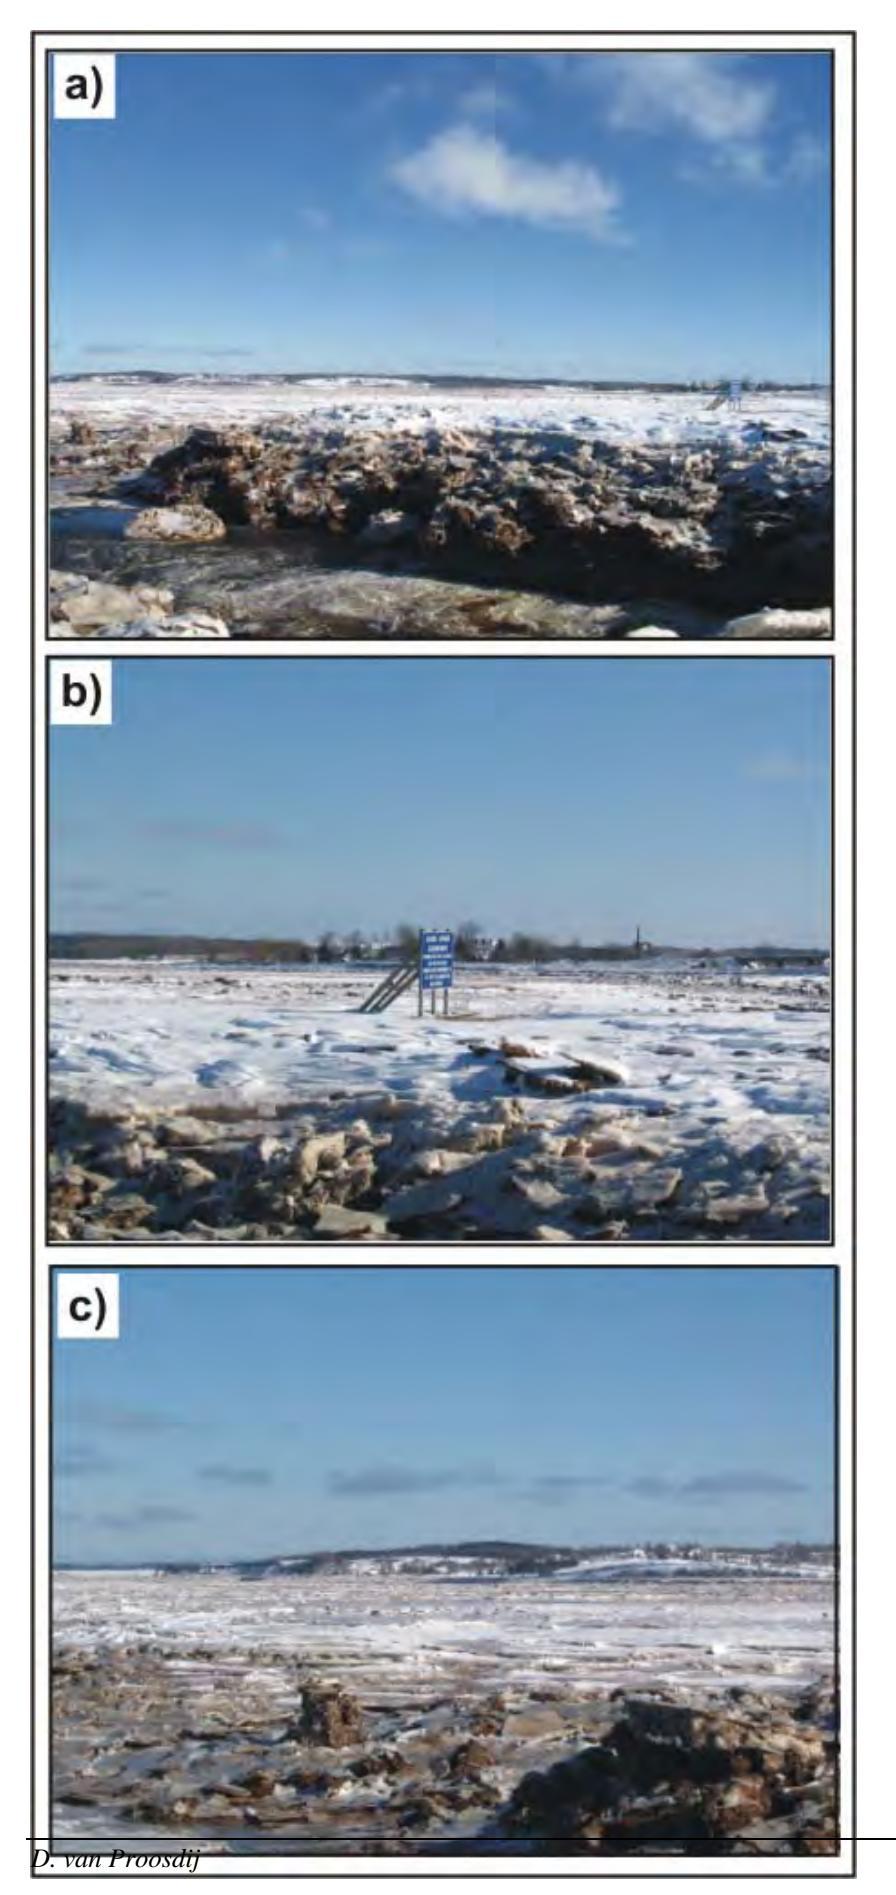
Figure 7 (left): Ice conditions on January 31st, 2005 at a) from tide gate, b) along causeway channel from tide gate and c) N towards main body of marsh from land near Avon River channel. Photos by K. Carroll, NSDAF.

of ice crust over the marsh surface. An additional 75 cm were deposited between January 20 and 24th, adding to the layer currently present. Spring tides on January 25th (Figure 6) broke up this crust and floating ice and snow 'rafts' were seen floating over the marsh surface. By January 31st, these rafts were observed over the entire marsh surface (Figure 7 and 8).

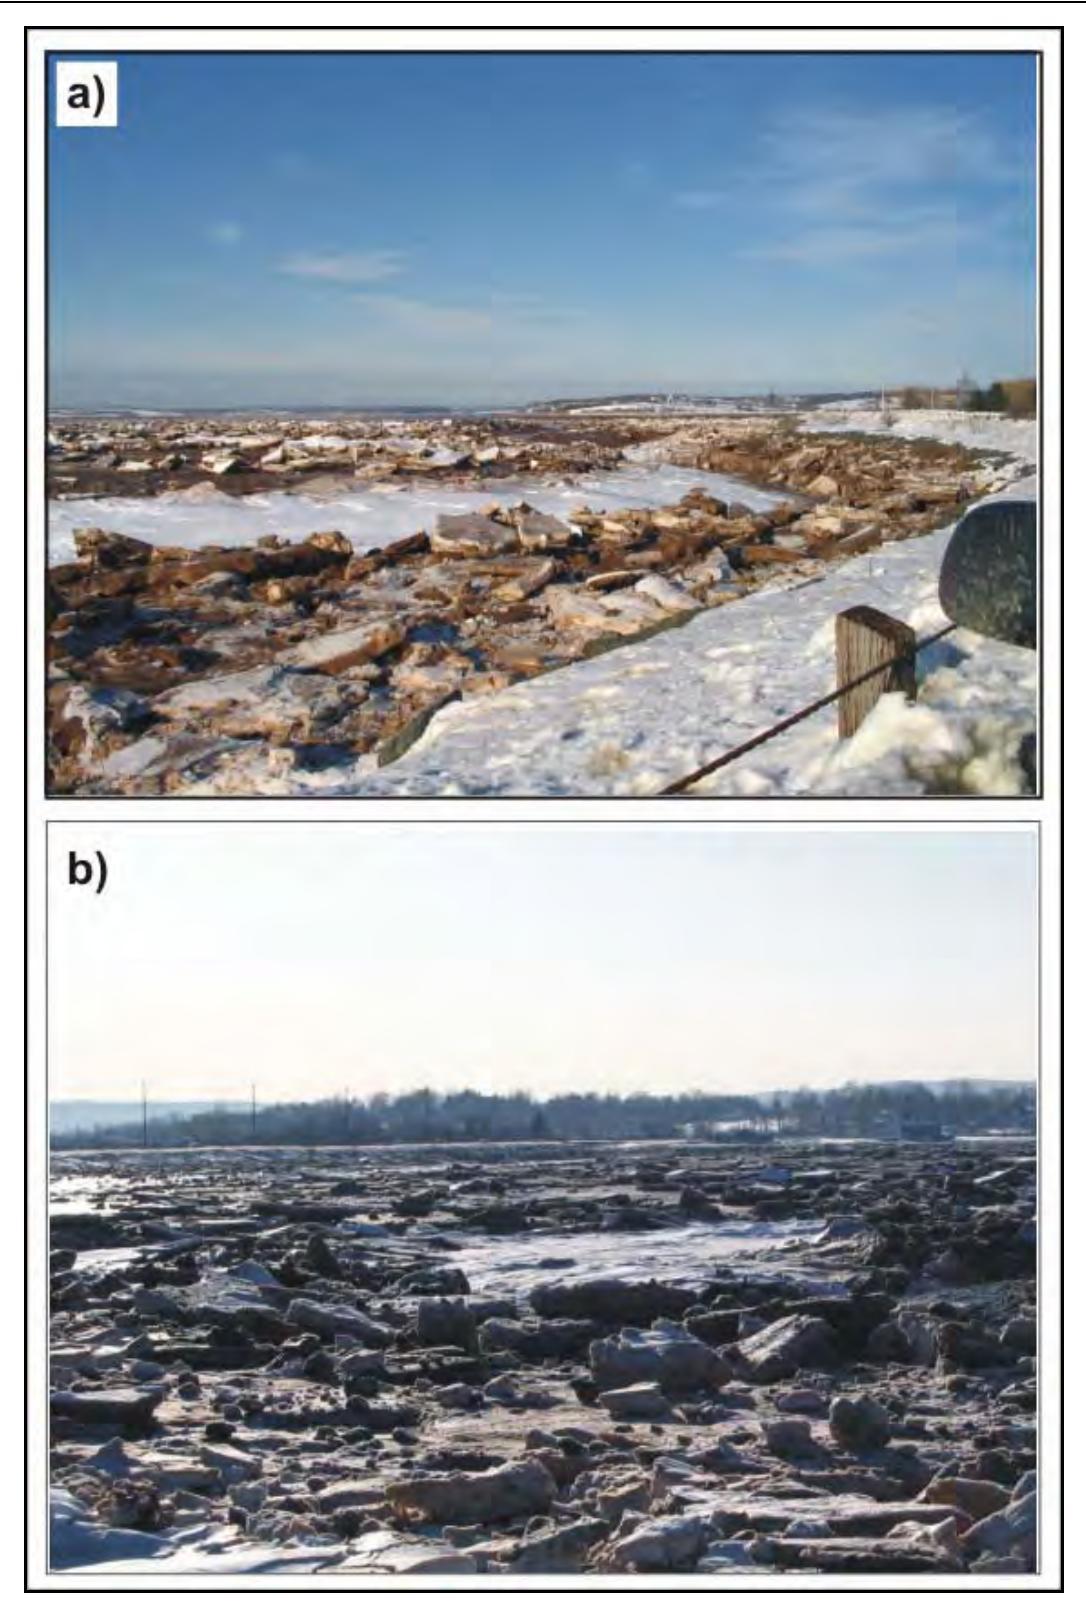
Figure 8: Ice blocks rafted in during spring tide near a) tourist bureau and b) along causeway channel looking west towards tide gate. Photos by K. Carroll.

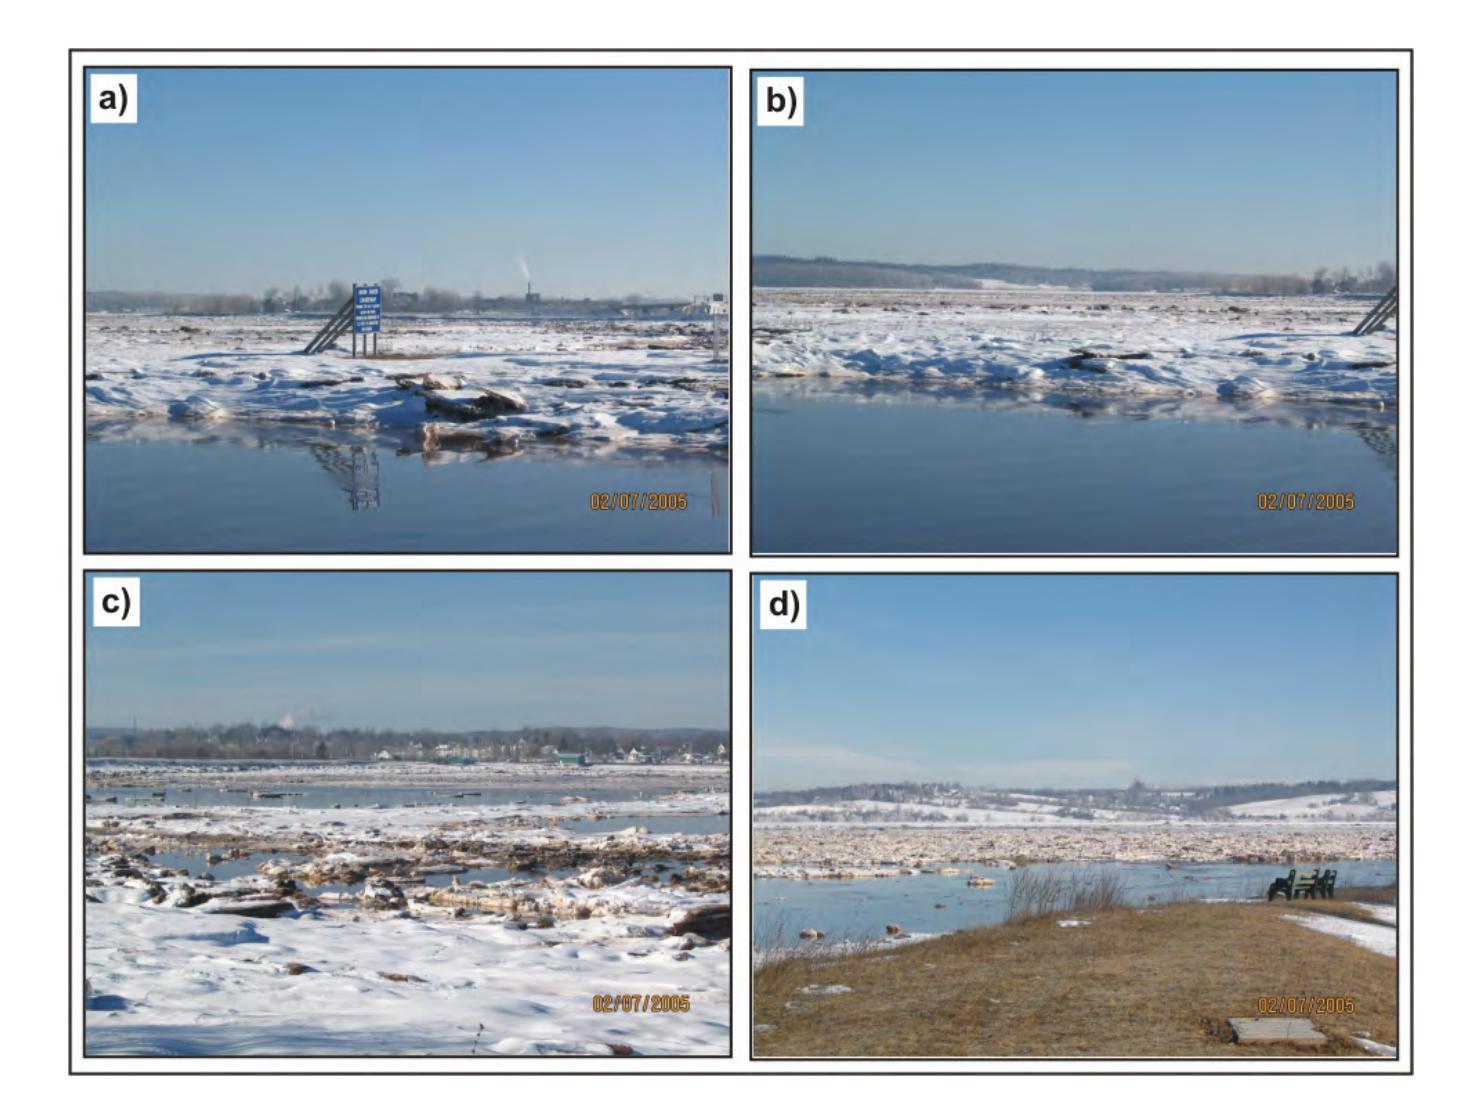
Figure 9: Winter conditions on Feb 7, 2005 on rising spring tide a) from tide gate towards causeway channel, b) from tide gate out to main body of marsh, c) from east side of causeway looking west toward tide gate and d) from tourist bureau dyke towards NW corner of marsh. Photos by K. Carroll, NSDAF.

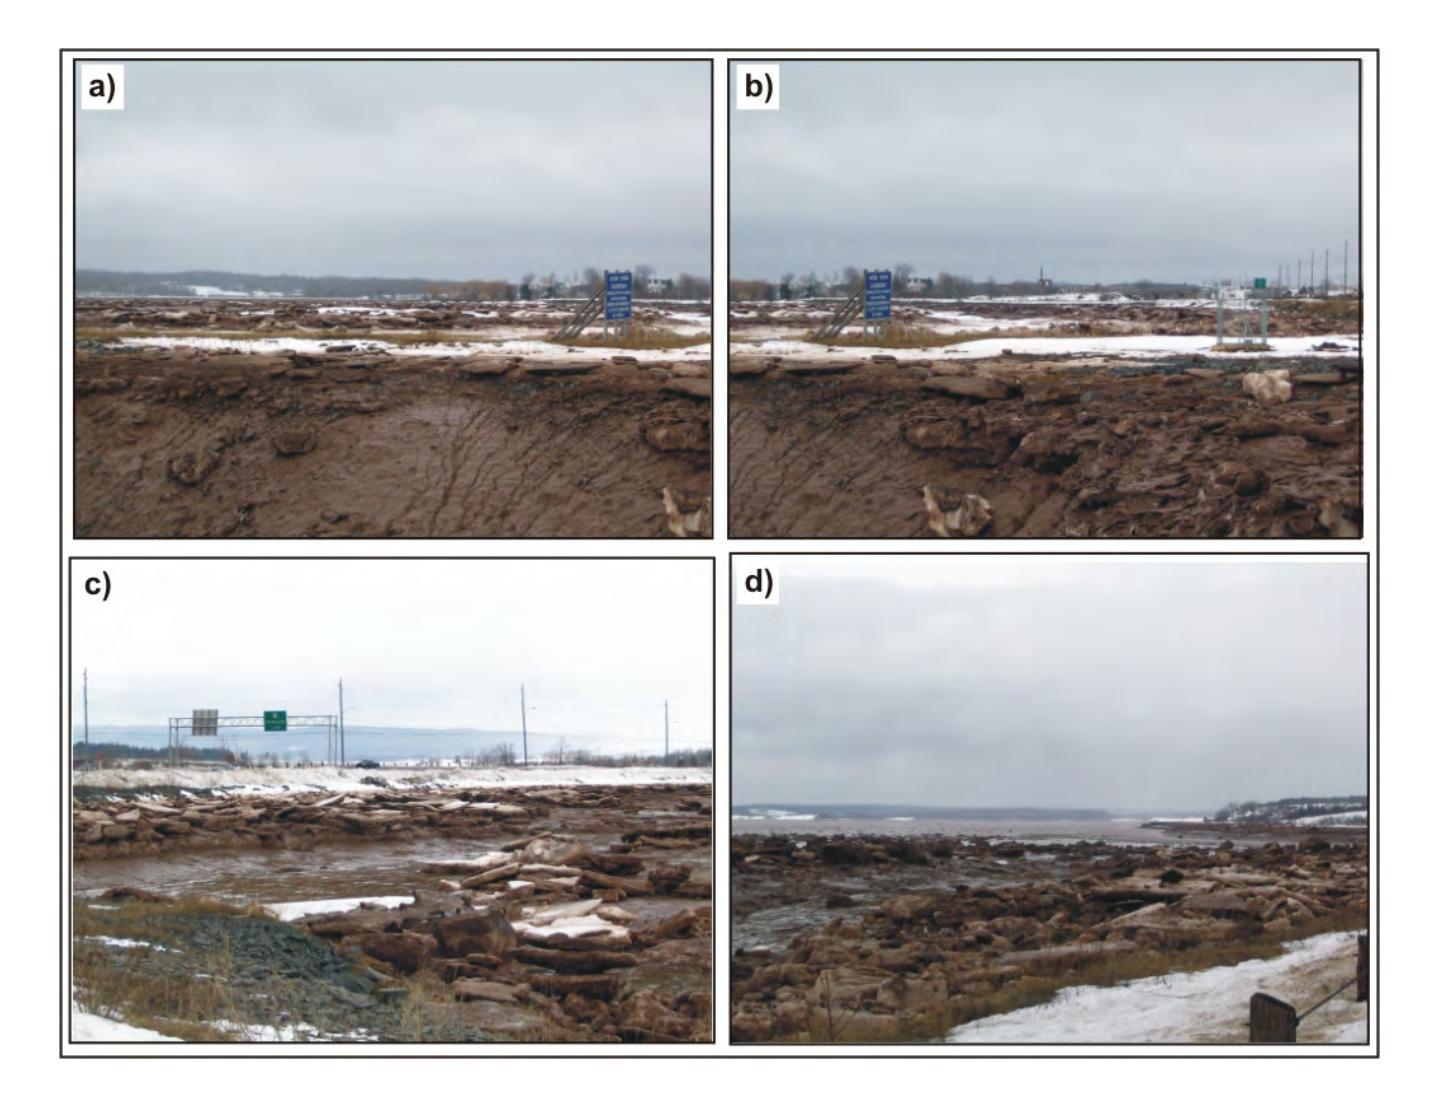
Figure 10: Winter conditions on Feb 11, 2005 after period of spring tides a) from tide gate out to main body of marsh, b) from tide gate towards causeway channel, c) from east side of causeway looking west toward tide gate and d) from tourist bureau dyke towards NW corner of marsh. Photos by K. Carroll, NSDAF. Note large ice pans which will remain on the marsh surface through the upcoming sequence of neap tides. In addition, layers of ice rafts can form steep sided banks along tidal creek channels as seen in photo C.

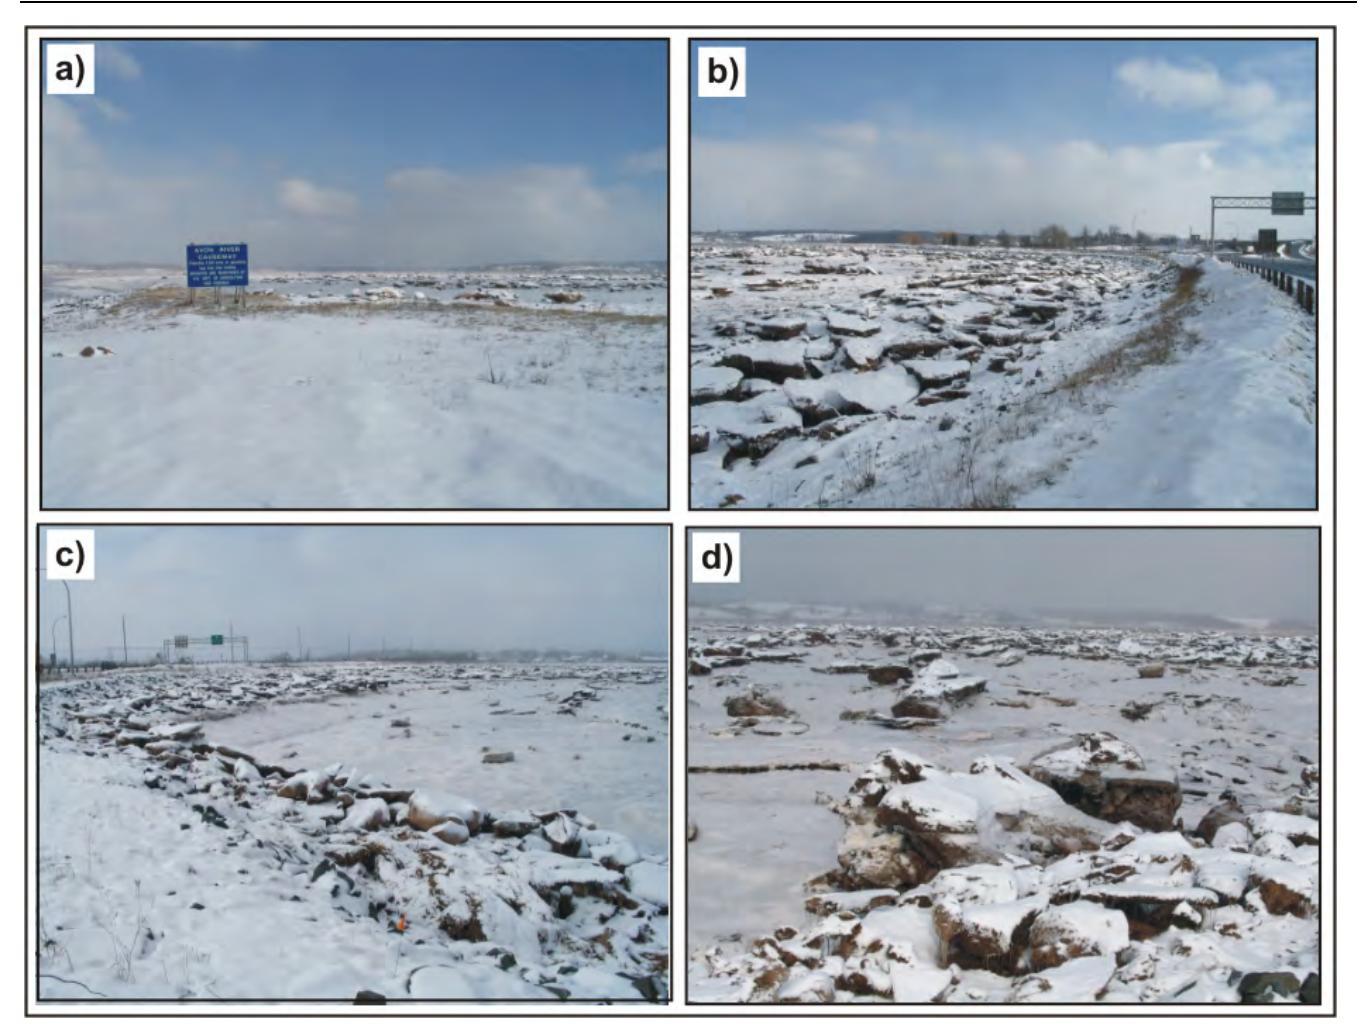
Figure 11 (above): Winter conditions on Feb 25, 2005 entering into spring tides a) from tide gate out to main body of marsh, b) from west end of causeway looking east long causeway channel, c) from east side of causeway looking west toward tide gate and d) from base of tourist bureau dyke towards NW corner of marsh. Photos by D. van Proosdij.

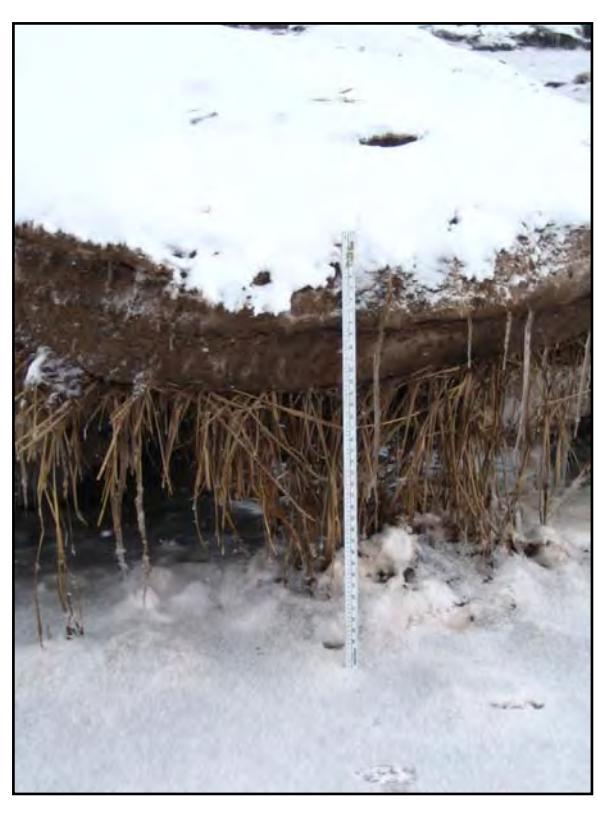
Figure 12 (at left): Drift ice with attached vegetative matter on Feb 25, 2005. The adhered vegetation in this example contains only dead above ground litter and does not contain root matter. Root matter is incorporated when an ice block freezes to the marsh surface and is later re-suspended on a spring tide, ripping out a mat of vegetation. This process results in depressions on the marsh surface which are evident in the spring particularly along the western and northern sections of the marsh. Photo by D. van Proosdij.

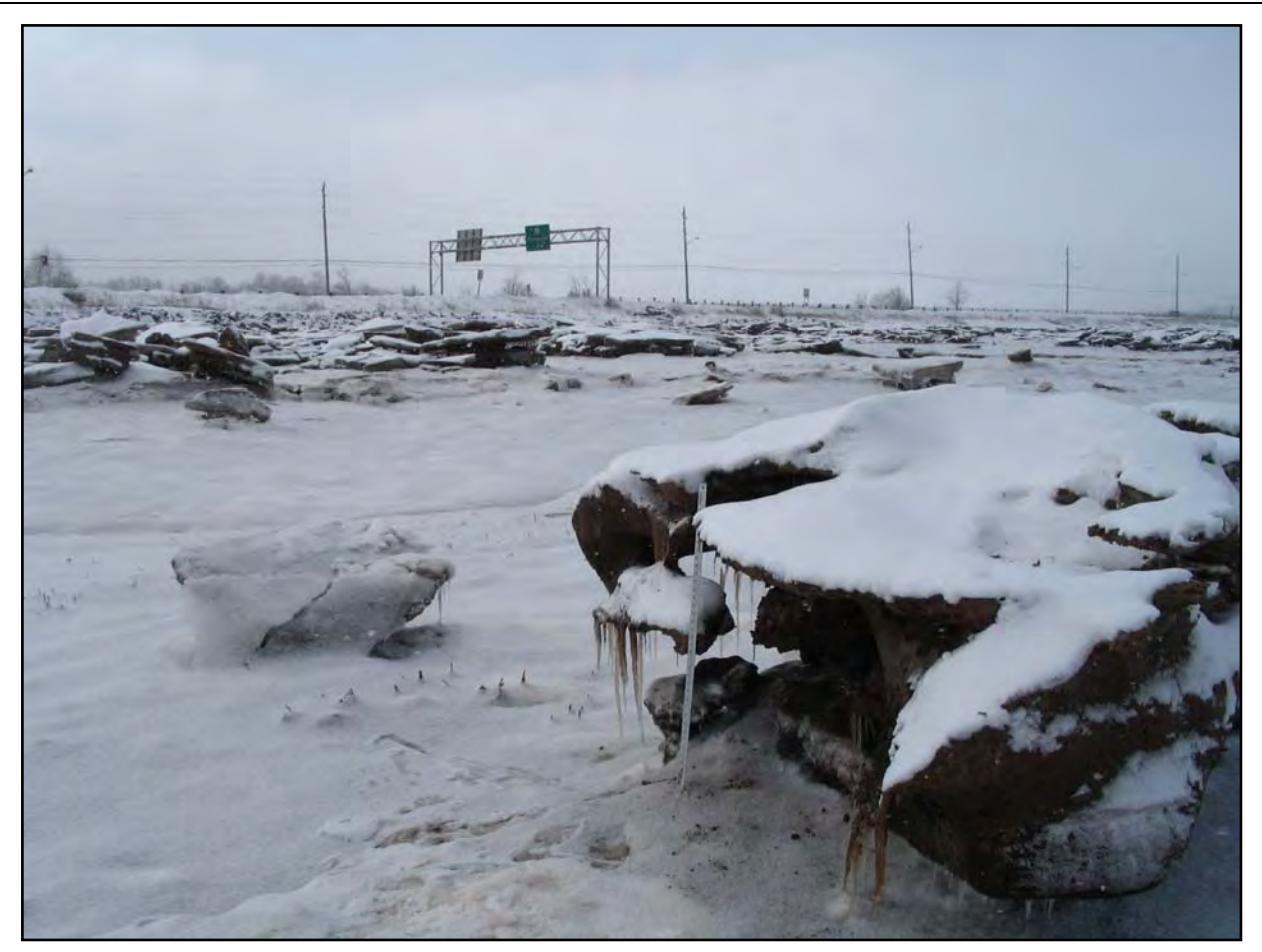
Figure 13 (above): Ice block near causeway channel. Meter stick for scale. Photo by D. van Proosdij, Feb 25, 2005

As mentioned previously, a number of ice blocks can coalesce over a series of tides, forming large amalgamations of sediment, ice and vegetative matter (Figure 13). Many of these exceeded 1.5 m in height and 2 m in diameter (Figure 14). Some may also include coarse sediment and rocks derived from the causeway toe itself.
