Monitoring Seasonal Changes in Surface Elevation of Intertidal Environments near the Windsor Causeway

Dr. Danika van Proosdij Department of Geography

May 18, 2005

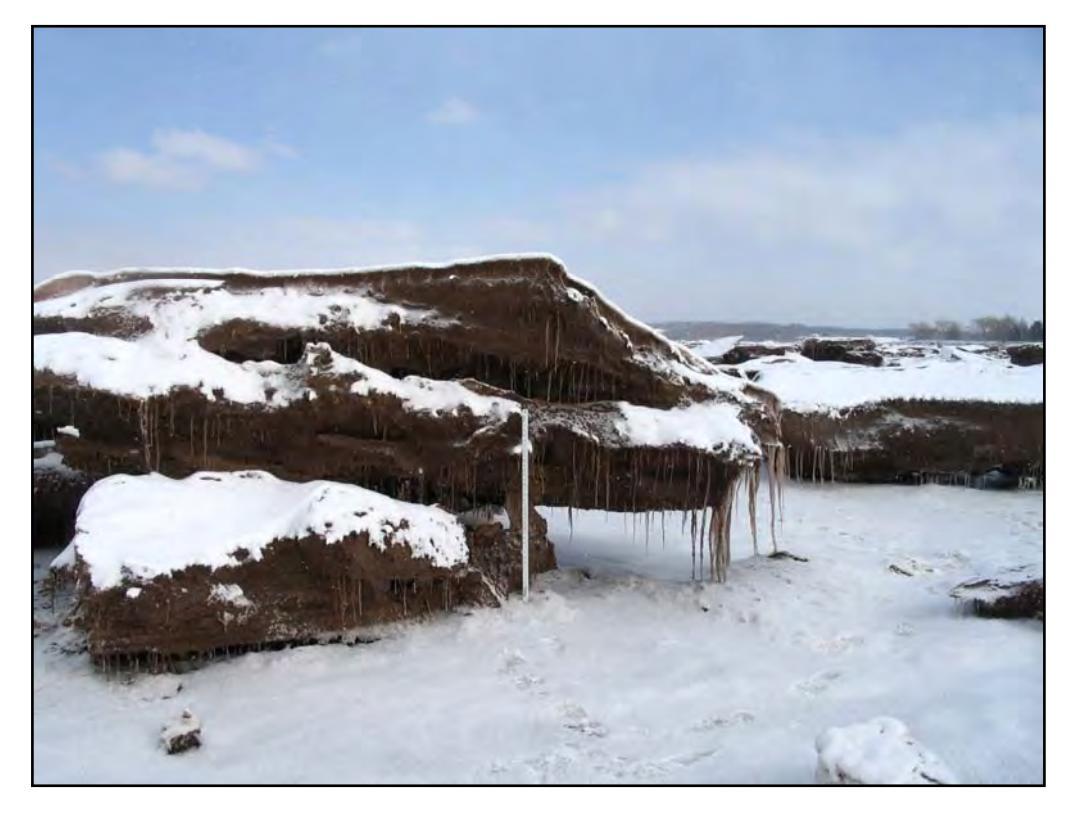
Figure 14: Layered shorefast ice block formed along causeway channel near L7-3sc. Note covering of ice by layer of sediment. Meter stick for scale. Photo by D. van Proosdij, Feb. 25, 2005.

As mentioned previously, a number of ice blocks can coalesce over a series of tides, forming large amalgamations of sediment, ice and vegetative matter (Figure 13). Many of these exceeded 1.5 m in height and 2 m in diameter (Figure 14). Some may also include coarse sediment and rocks derived from the causeway toe itself.

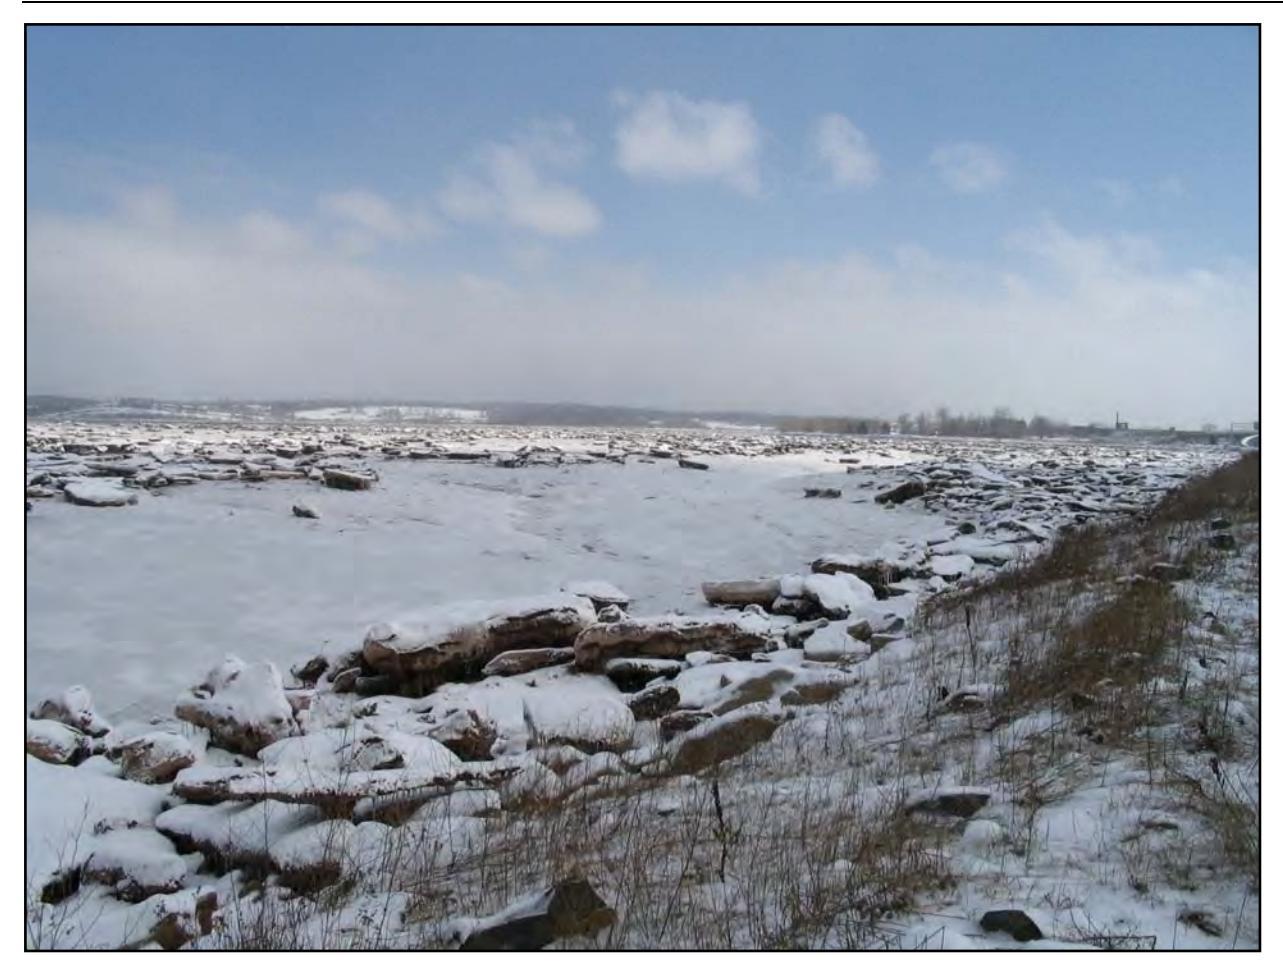
Figure 15: Drift ice along causeway tidal creek channel. Note the absence of ice in the central section of the channel since this area is flooded every tide. Photo by D. van Proosdij on Feb. 25, 2005.

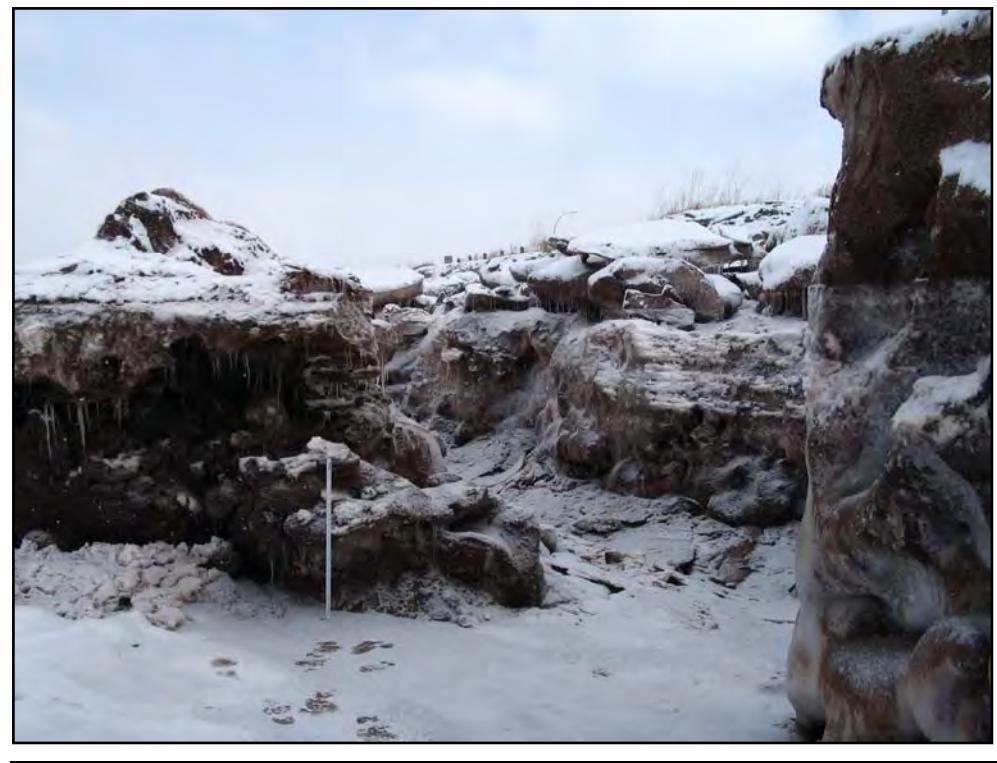
Figure 16: Approximately 2.5 m high by 4 m block of ice blocking creek channel. Meter stick for scale. Photo by D. van Proosdij on Feb. 25, 2005.

Sometime between February 11th and the 25th, a large ice block lodged itself within the large eastern creek channel (Figure 16). This effectively reduced the cross sectional area of the creek, likely increasing flow velocities within the remaining channel and eroding the outer creek bank. This process was observed visually on the rising spring tide later in the day on the 25th. Since tidal flow was blocked, sedimentation was observed on the downstream edge of the ice block. This channelization of flow has the potential to change the location of the creek thalweg. However, since topographic surveys were not conducted in May 2005, this could not be verified.

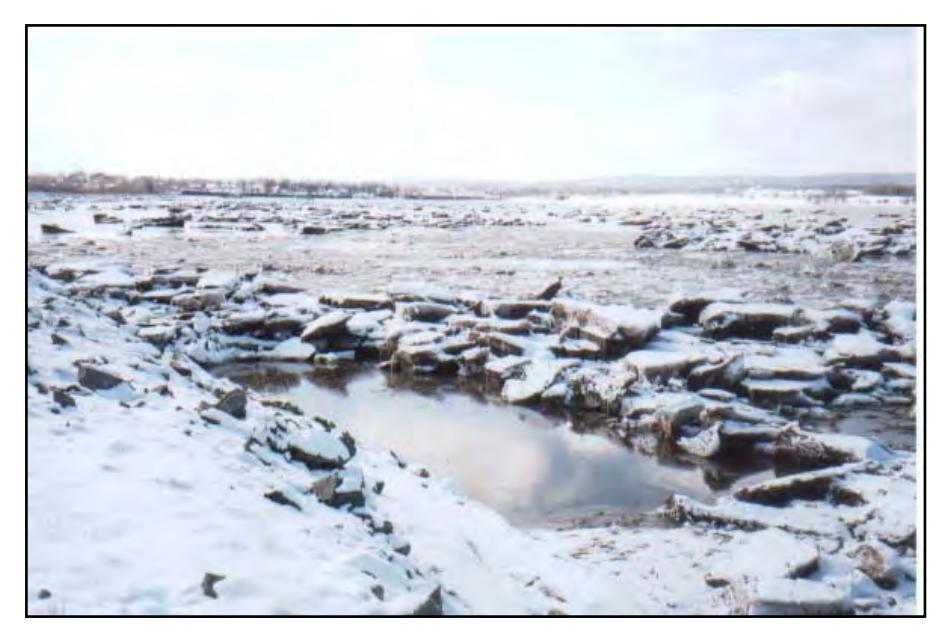
Figure 17: Temporary pool of tidal water formed along dyke near tourist bureau. Photo by D. van Proosdij, Feb. 25, 2005.

Ice blocks may also accumulate and form the banks of temporary pools on the marsh surface (Figure 17). These pools trap the highly turbid waters entering into the system (Figure 18), creating favorable conditions for particle settling.

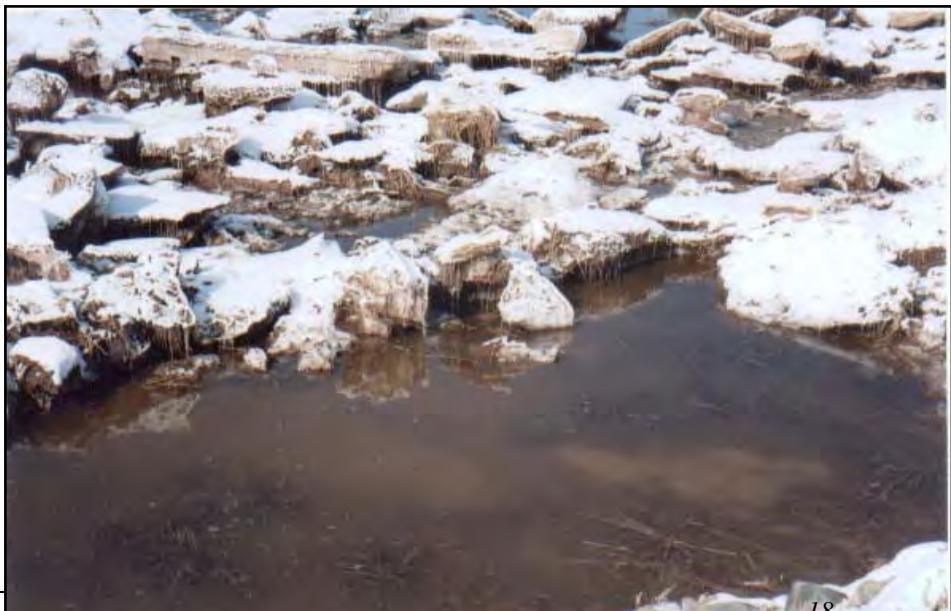
Figure 18: Plumes of sediment may be observed in suspension within these pools. In general, the suspended sediment concentrations are much higher during the winter months than during the summer. Photo by D. van Proosdij on Feb. 25, 2005.

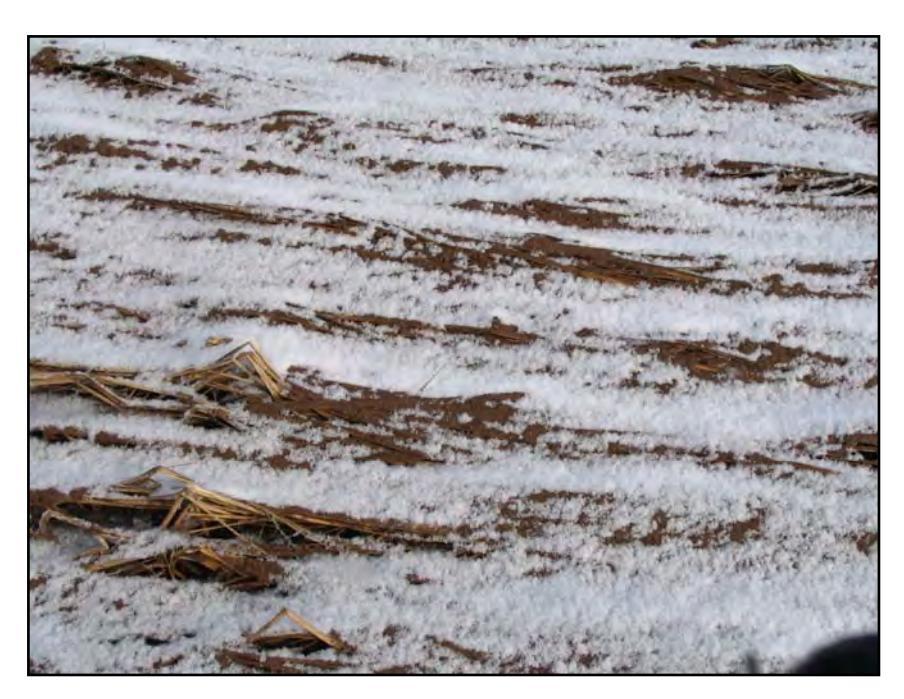
Figure 19: Sediment deposited over *Spartina alterniflora* along line 6. Overtime, the vegetation will decompose and be incorporated within the soil matrix. Photo by D. van Proosdij on Feb. 25, 2005.

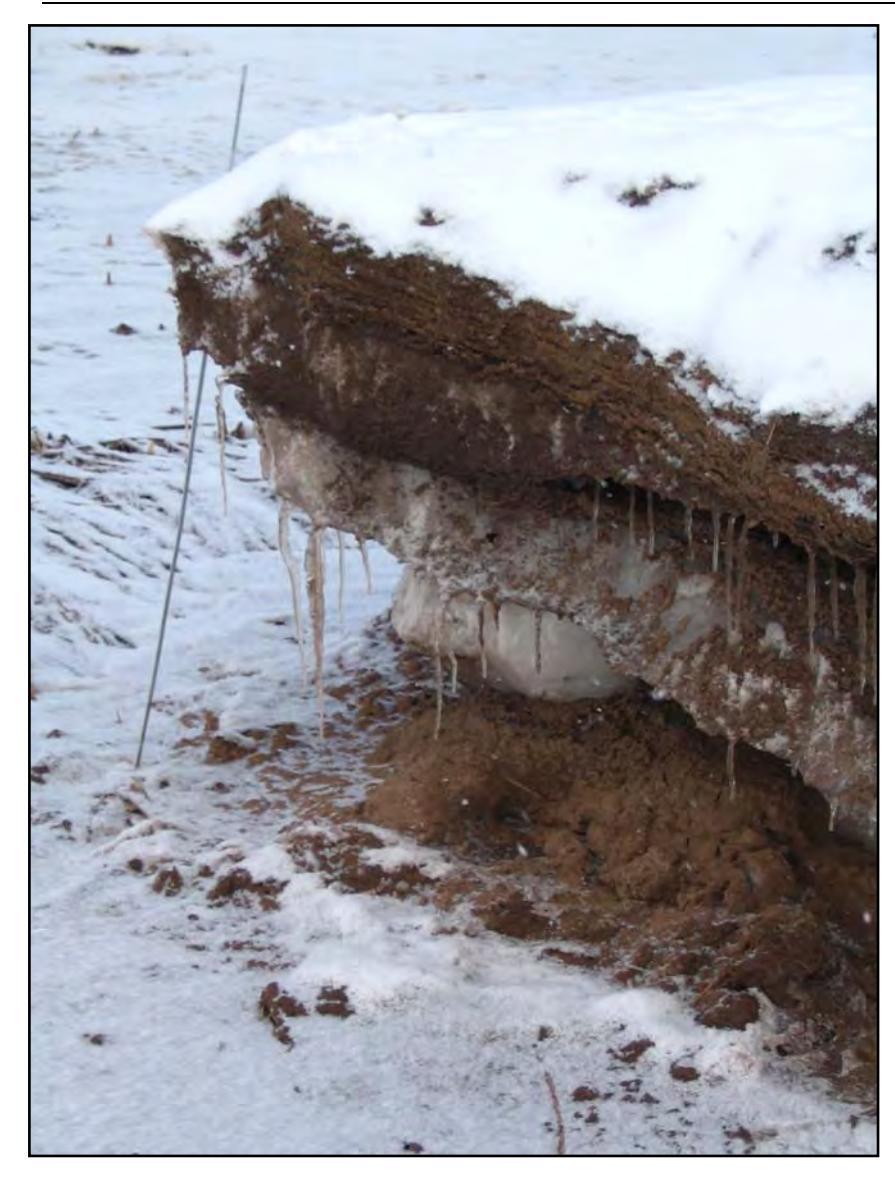
Figure 20 (at right): Sediment incorporated within matrix of ice block forming alternating layers of ice and sediment. Note sediment mound accumulating at base of the ice block. Meter stick for scale. Photo by D. van Proosdij on Feb. 25, 2005.

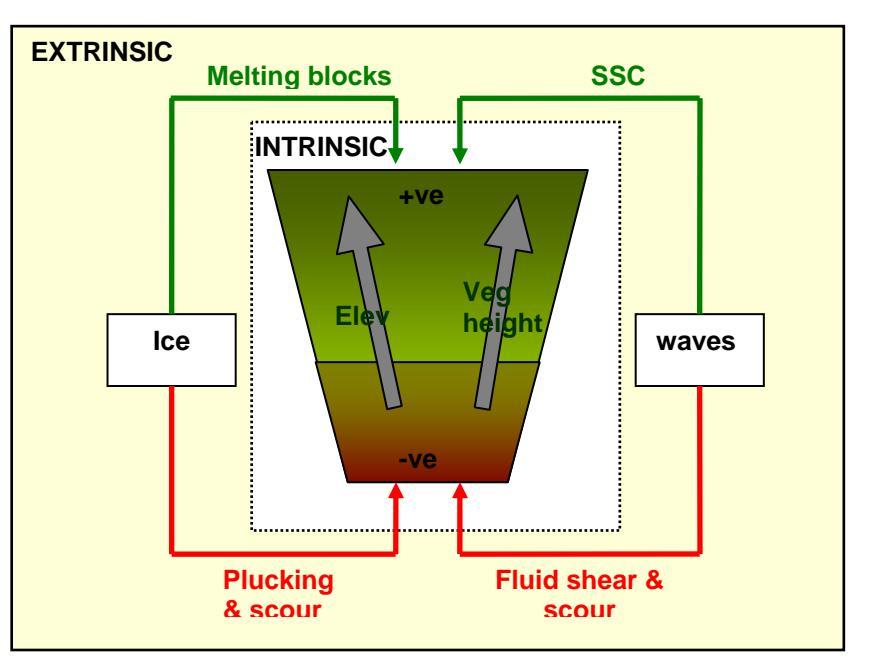
Figure 20: Preliminary conceptual model of factors controlling the change in surface elevation in the Windsor marsh / mudflat system. Ice and waves induce both positive and negative effects. Positive (+ve) effects result from melting ice blocks and high suspended sediment concentrations (SSC). Negative effects which will lower the surface include erosion from ice plucking and scour as well as direct surface shear from wave action. These external or extrinsic forces will be dampened (-ve) or enhanced (+ve) with increasing elevation within the tidal frame and vegetation height.

A preliminary conceptual model is presented in Figure 21 to summarize the main factors hypothesized to control the changes in surface elevation within this marsh /mudflat system. The model was developed based on data obtained from this study and ongoing studies within the upper Bay of Fundy (e.g. van Proosdij et al., in press; van Proosdij et al., 2004; Daborn et al., 2003; Davidson-Arnott et al., 2002; Ollearhead et al., 1999). Dominant controls include those with are extrinsic to the marsh system (wave activity, ice, tidal range) and those with are intrinsic to the system (elevation within tidal frame and vegetation). These intrinsic variables will in turn influence how the marsh surface will respond to these external forces.
